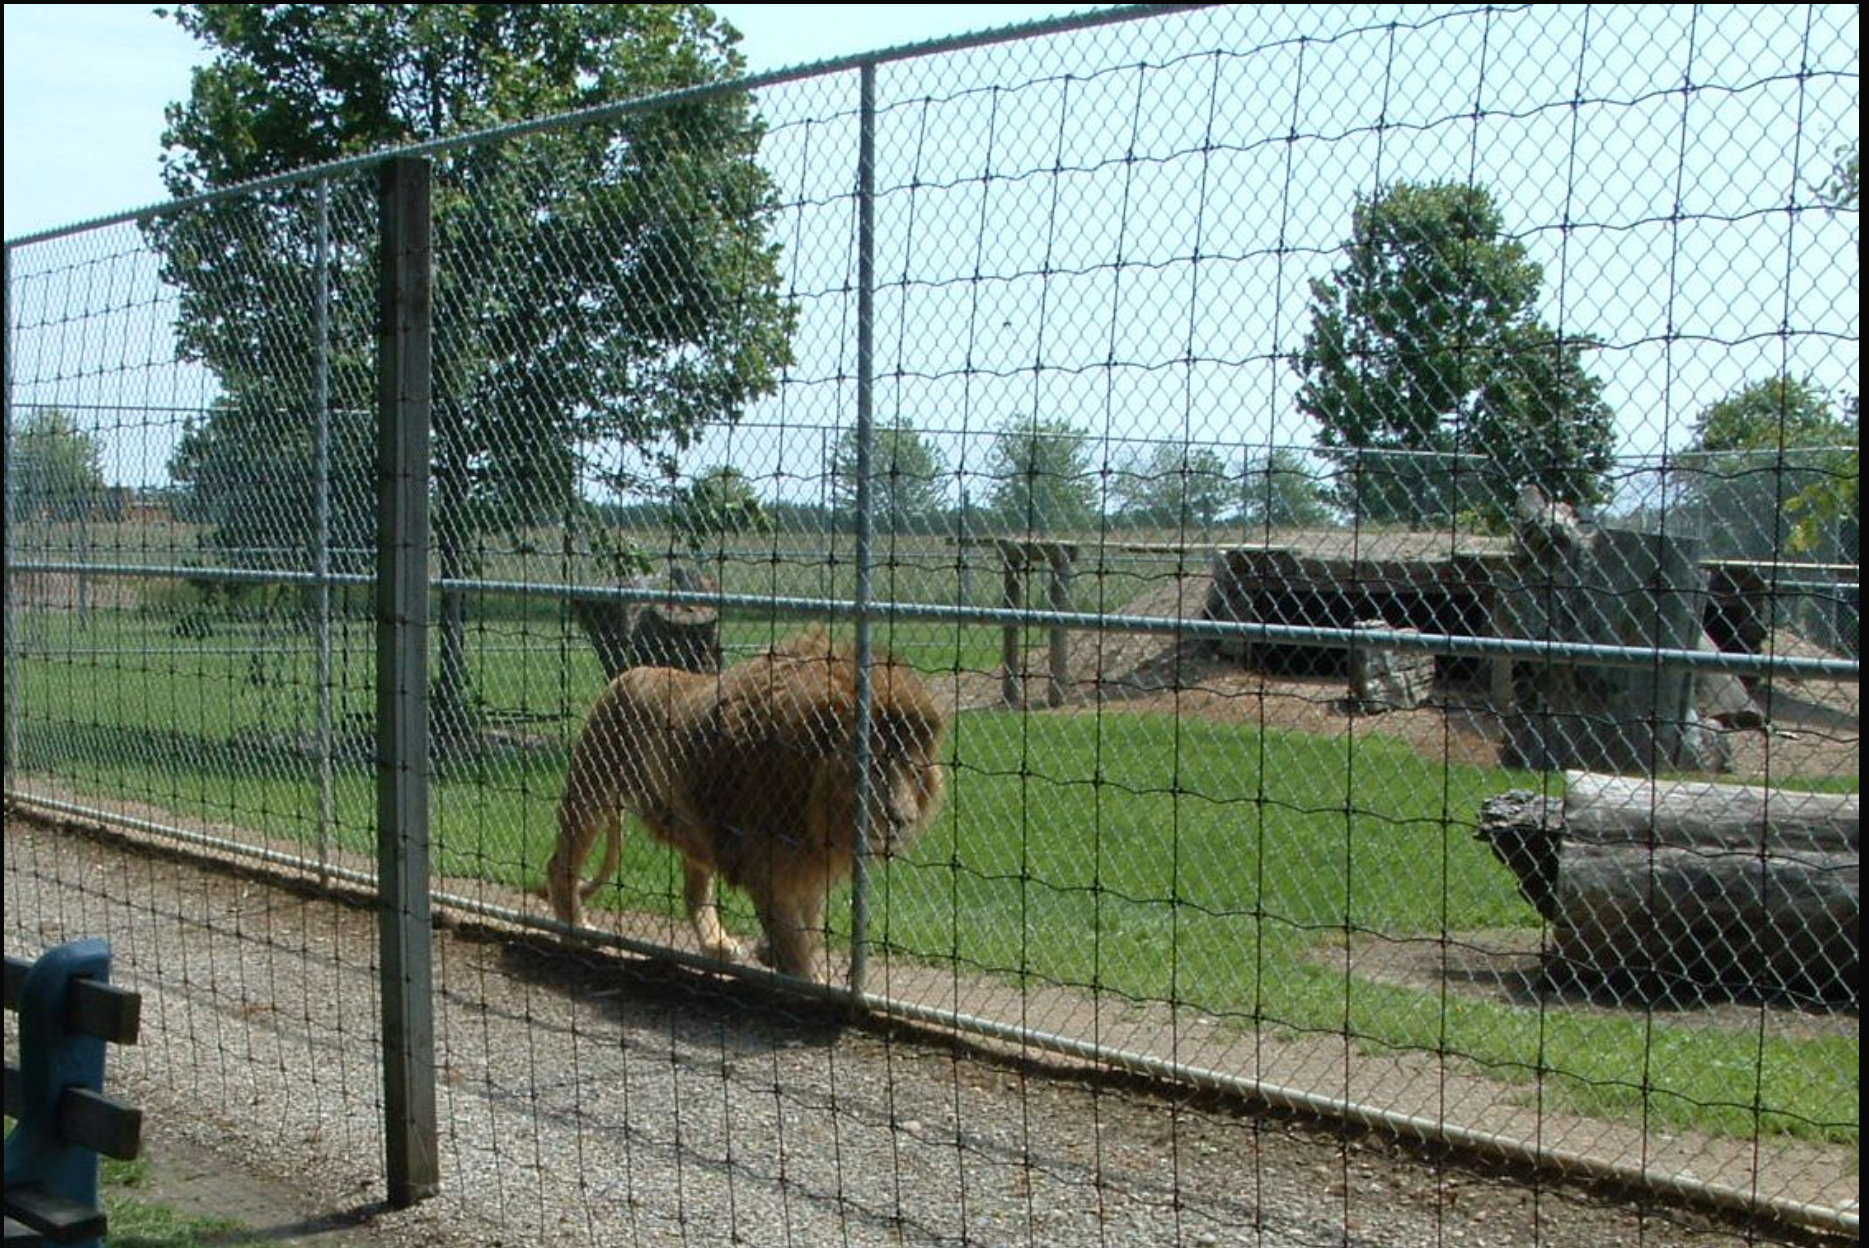
Adult lion paces along fence barrier estimated at 10 ft (3.04 m) in height. No overhang to discourage jumping or climbing. – Greenview Aviaries Park and Zoo 2010

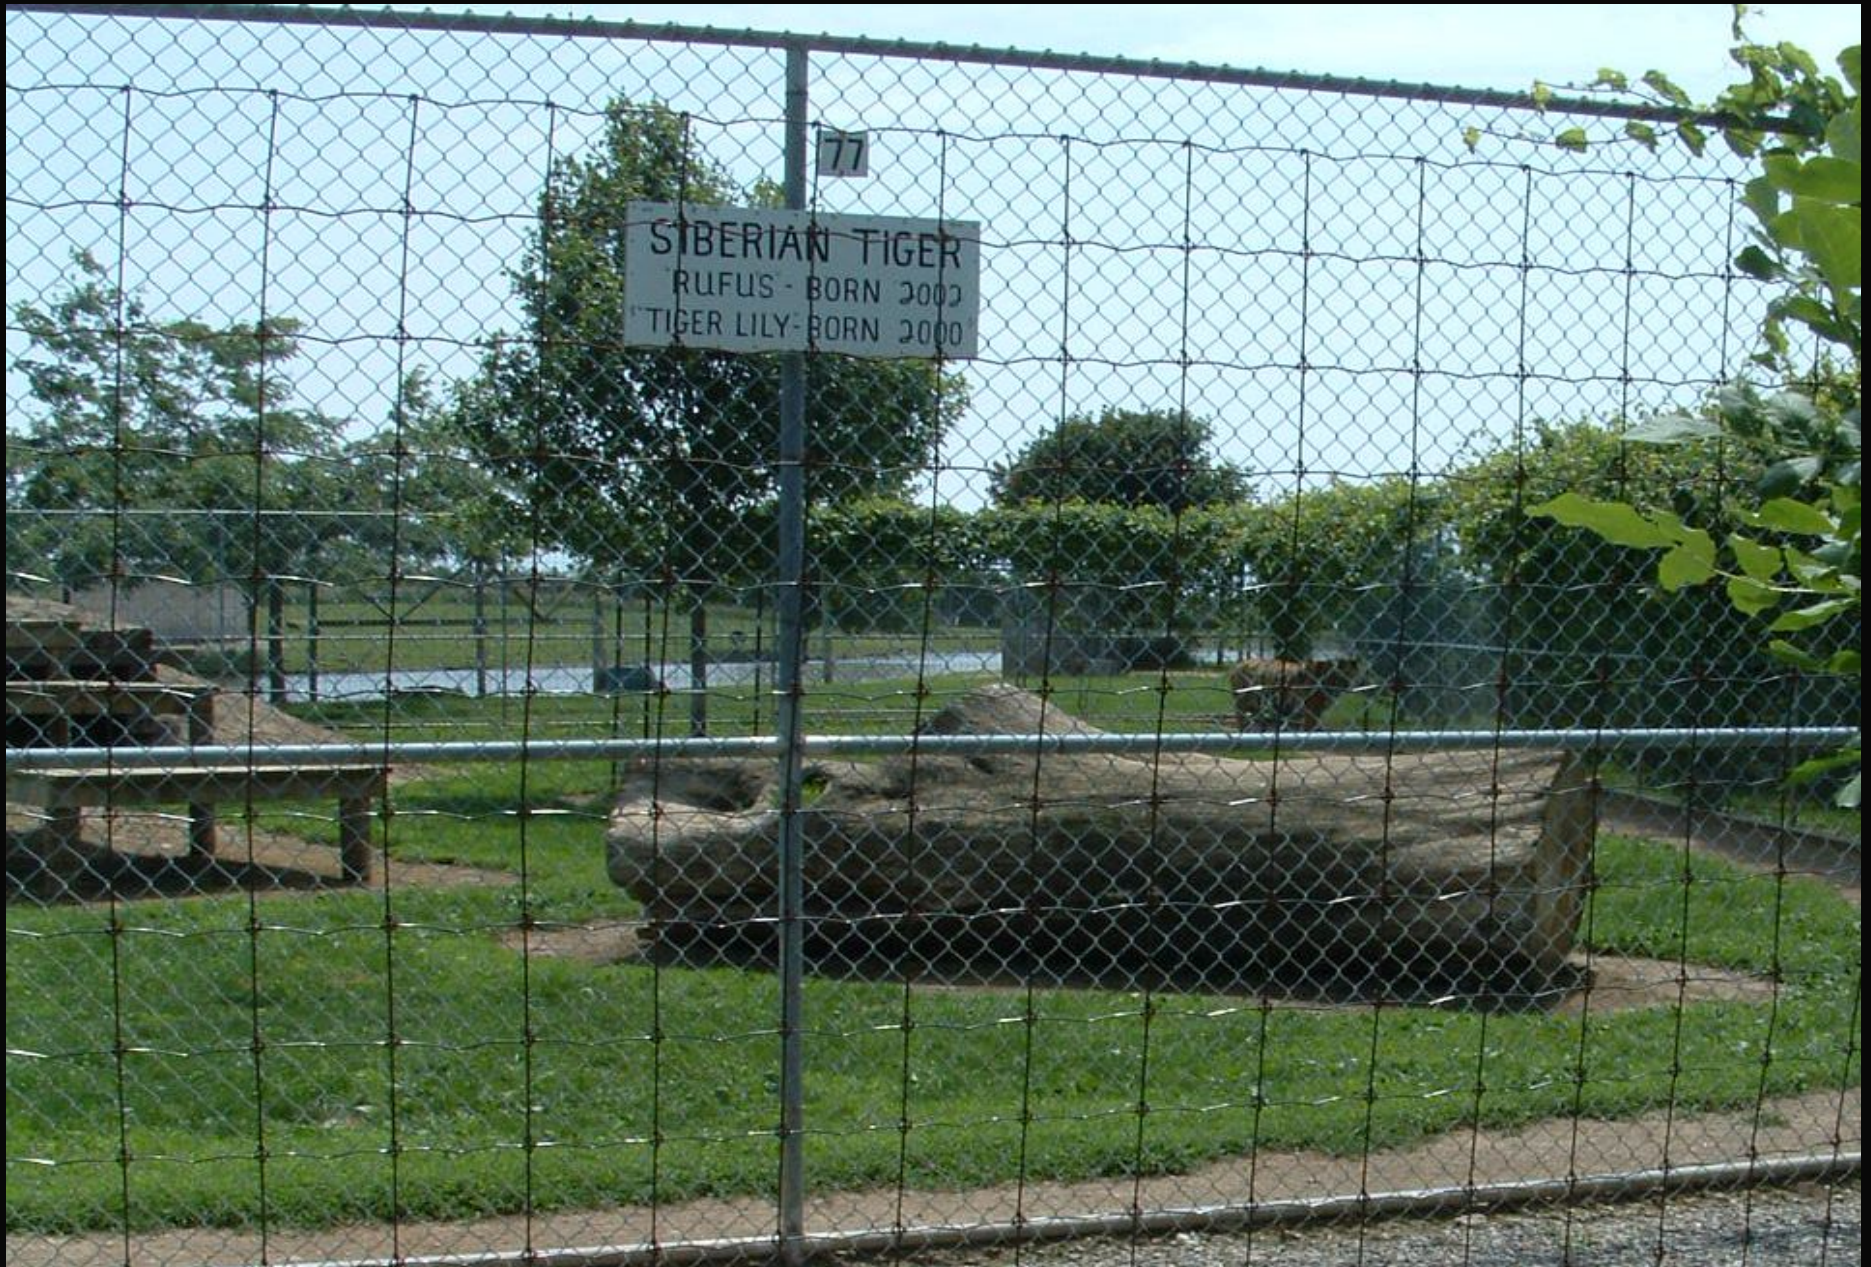
Tiger enclosure barrier estimated at 10 ft (3.04 m) in height. No overhang to discourage jumping or climbing. – Greenview Aviaries Park and Zoo 2010

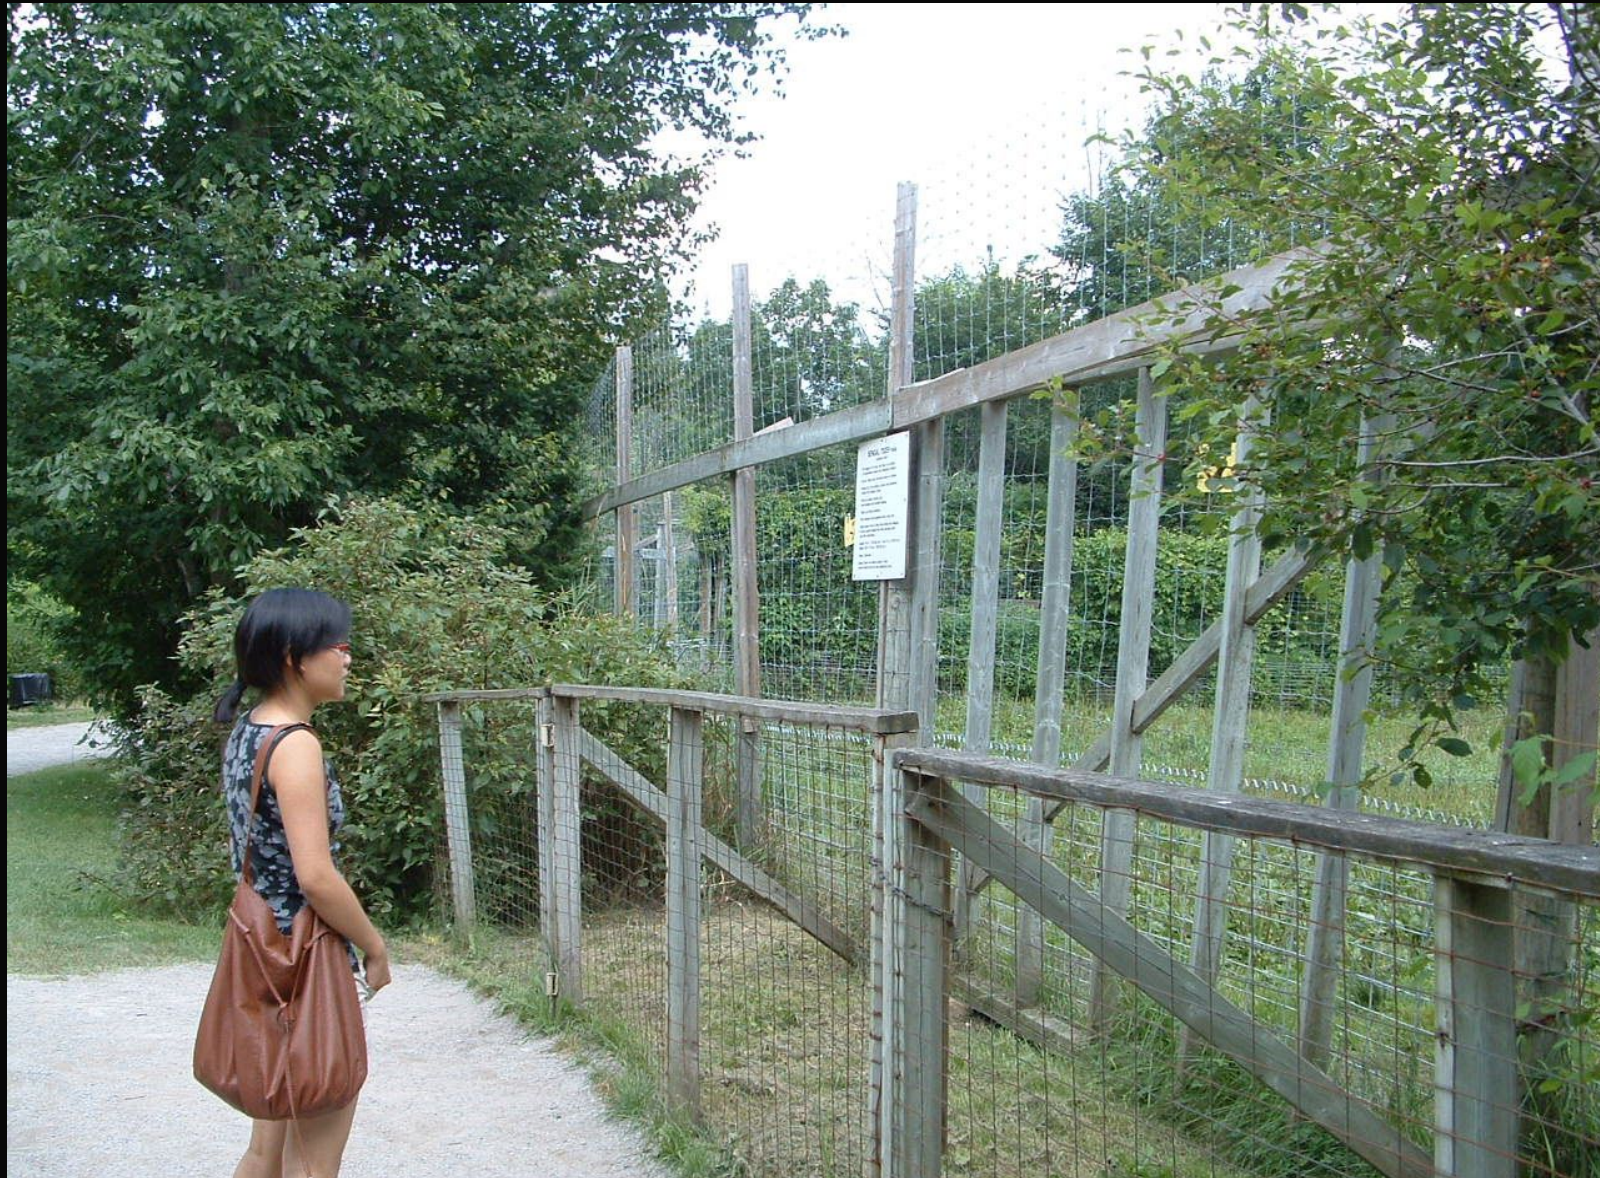
Tiger enclosure barrier constructed of deer fencing. Flimsy upper extension.  
No overhang. Total estimated height 12 ft (3.65 m) - Elmvale Jungle Zoo 2010

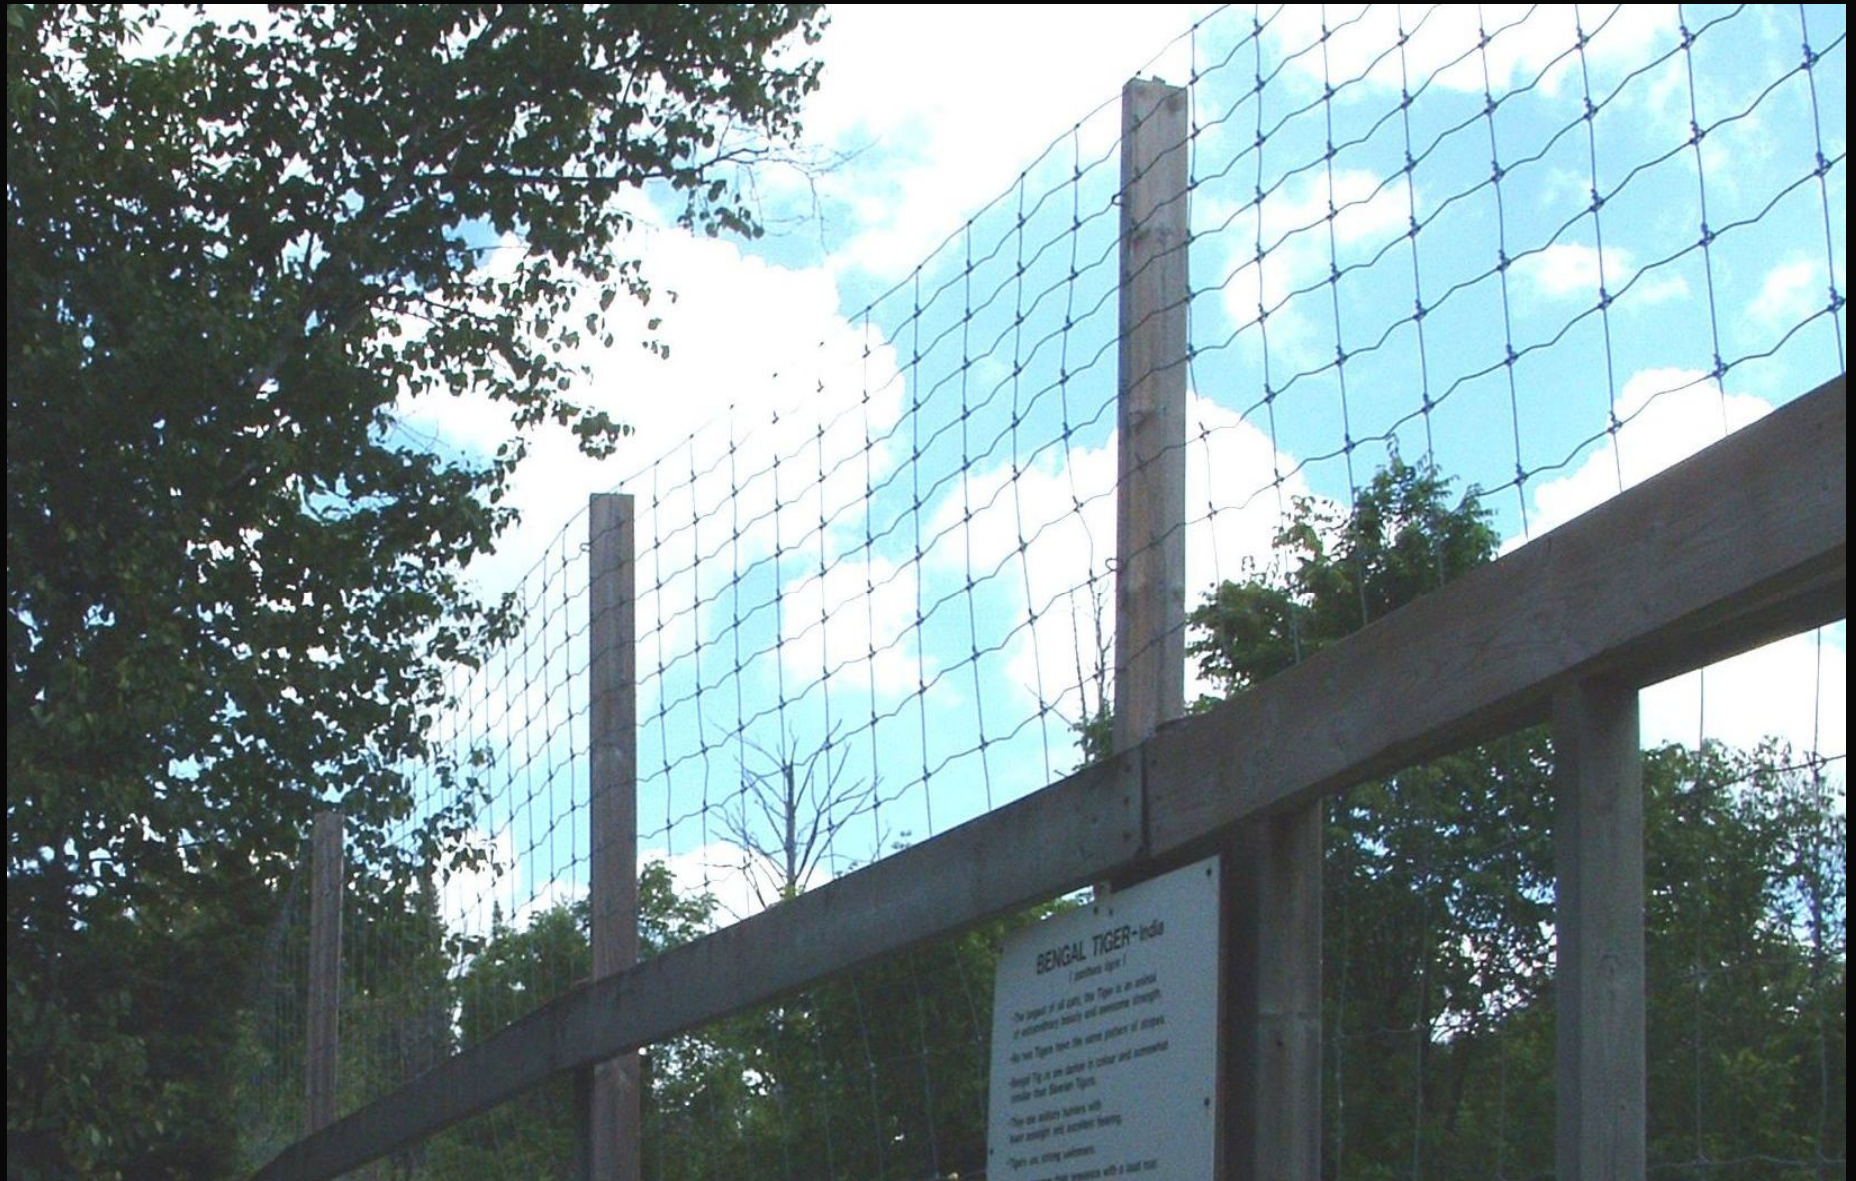
Close up of tiger enclosure barrier extension. Vertical struts are small. No horizontal struts along top for reinforcement. No overhang to discourage jumping. – Elmvale Jungle Zoo 2010

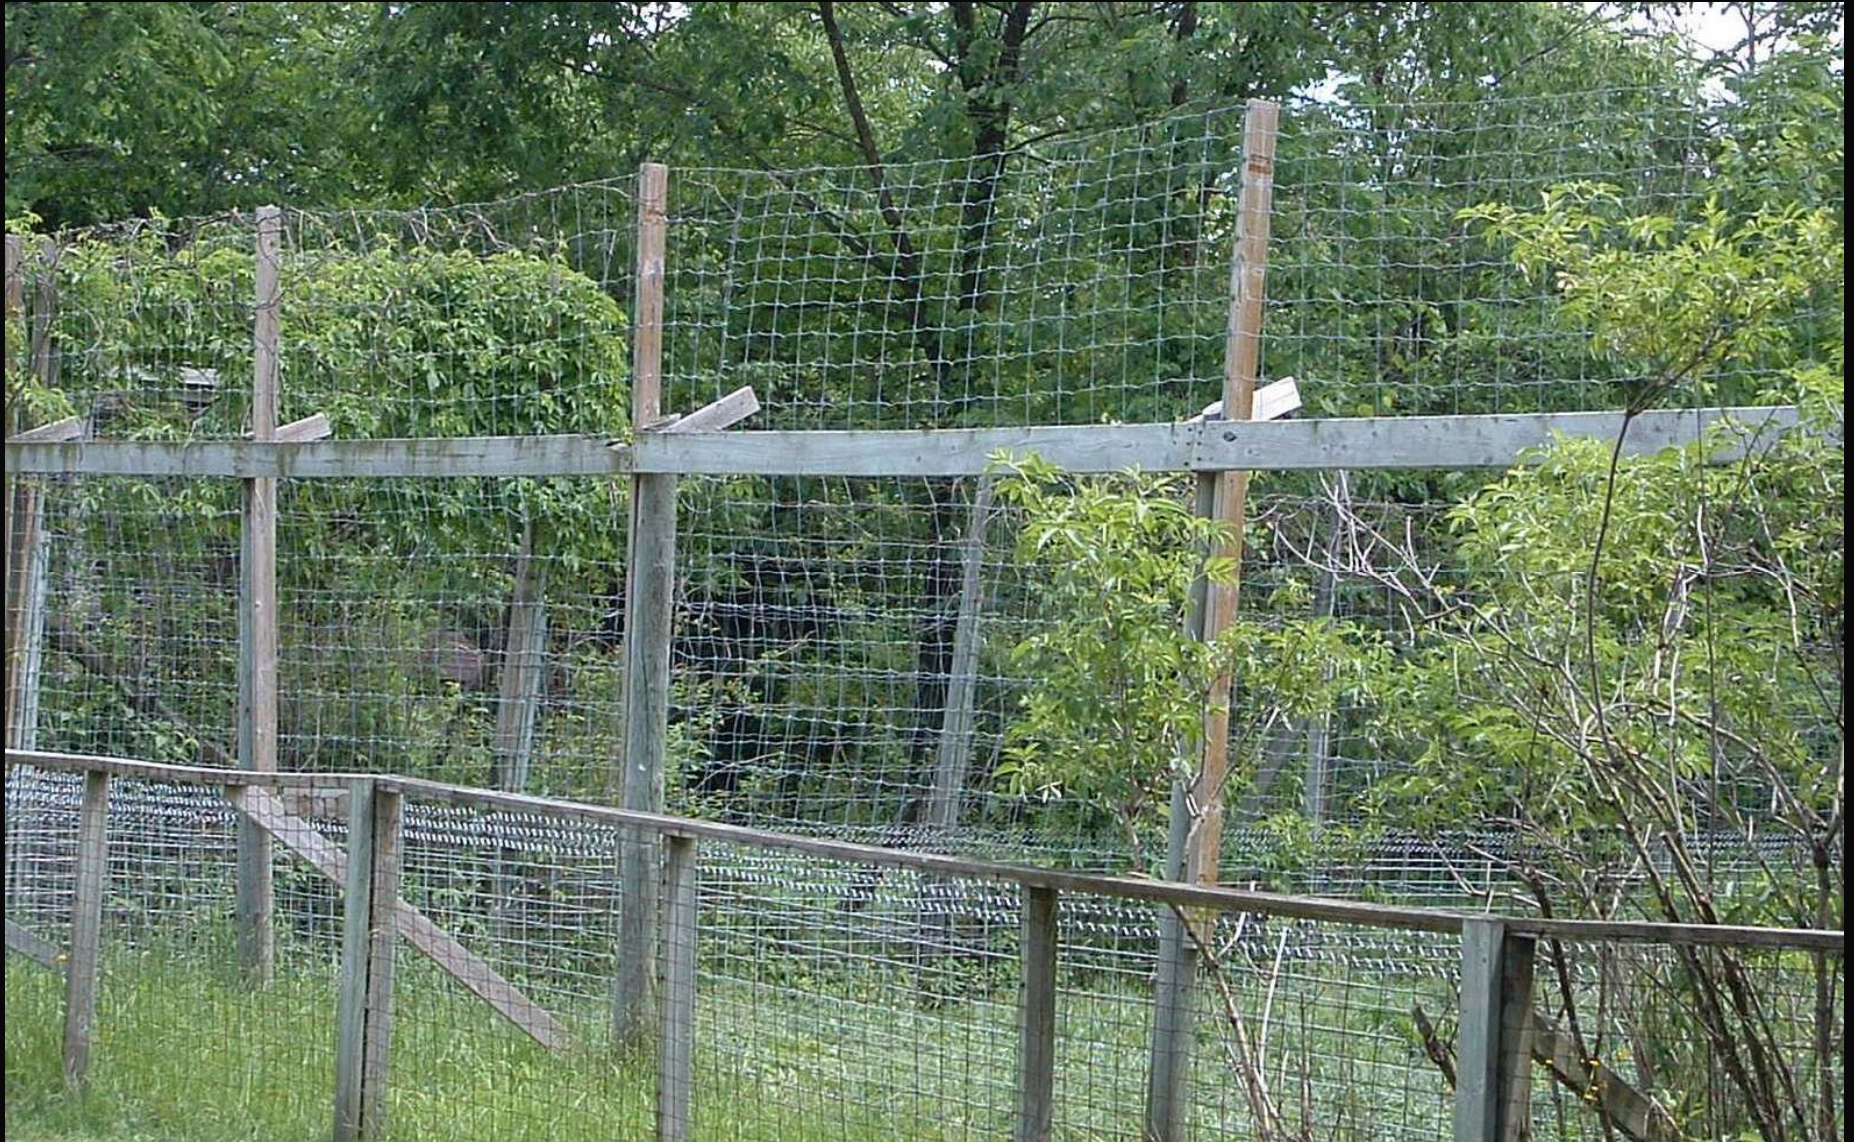
Tiger enclosure fence mesh is not taut, but appears loosely secured and poorly supported.  
Elmvale Jungle Zoo 2010

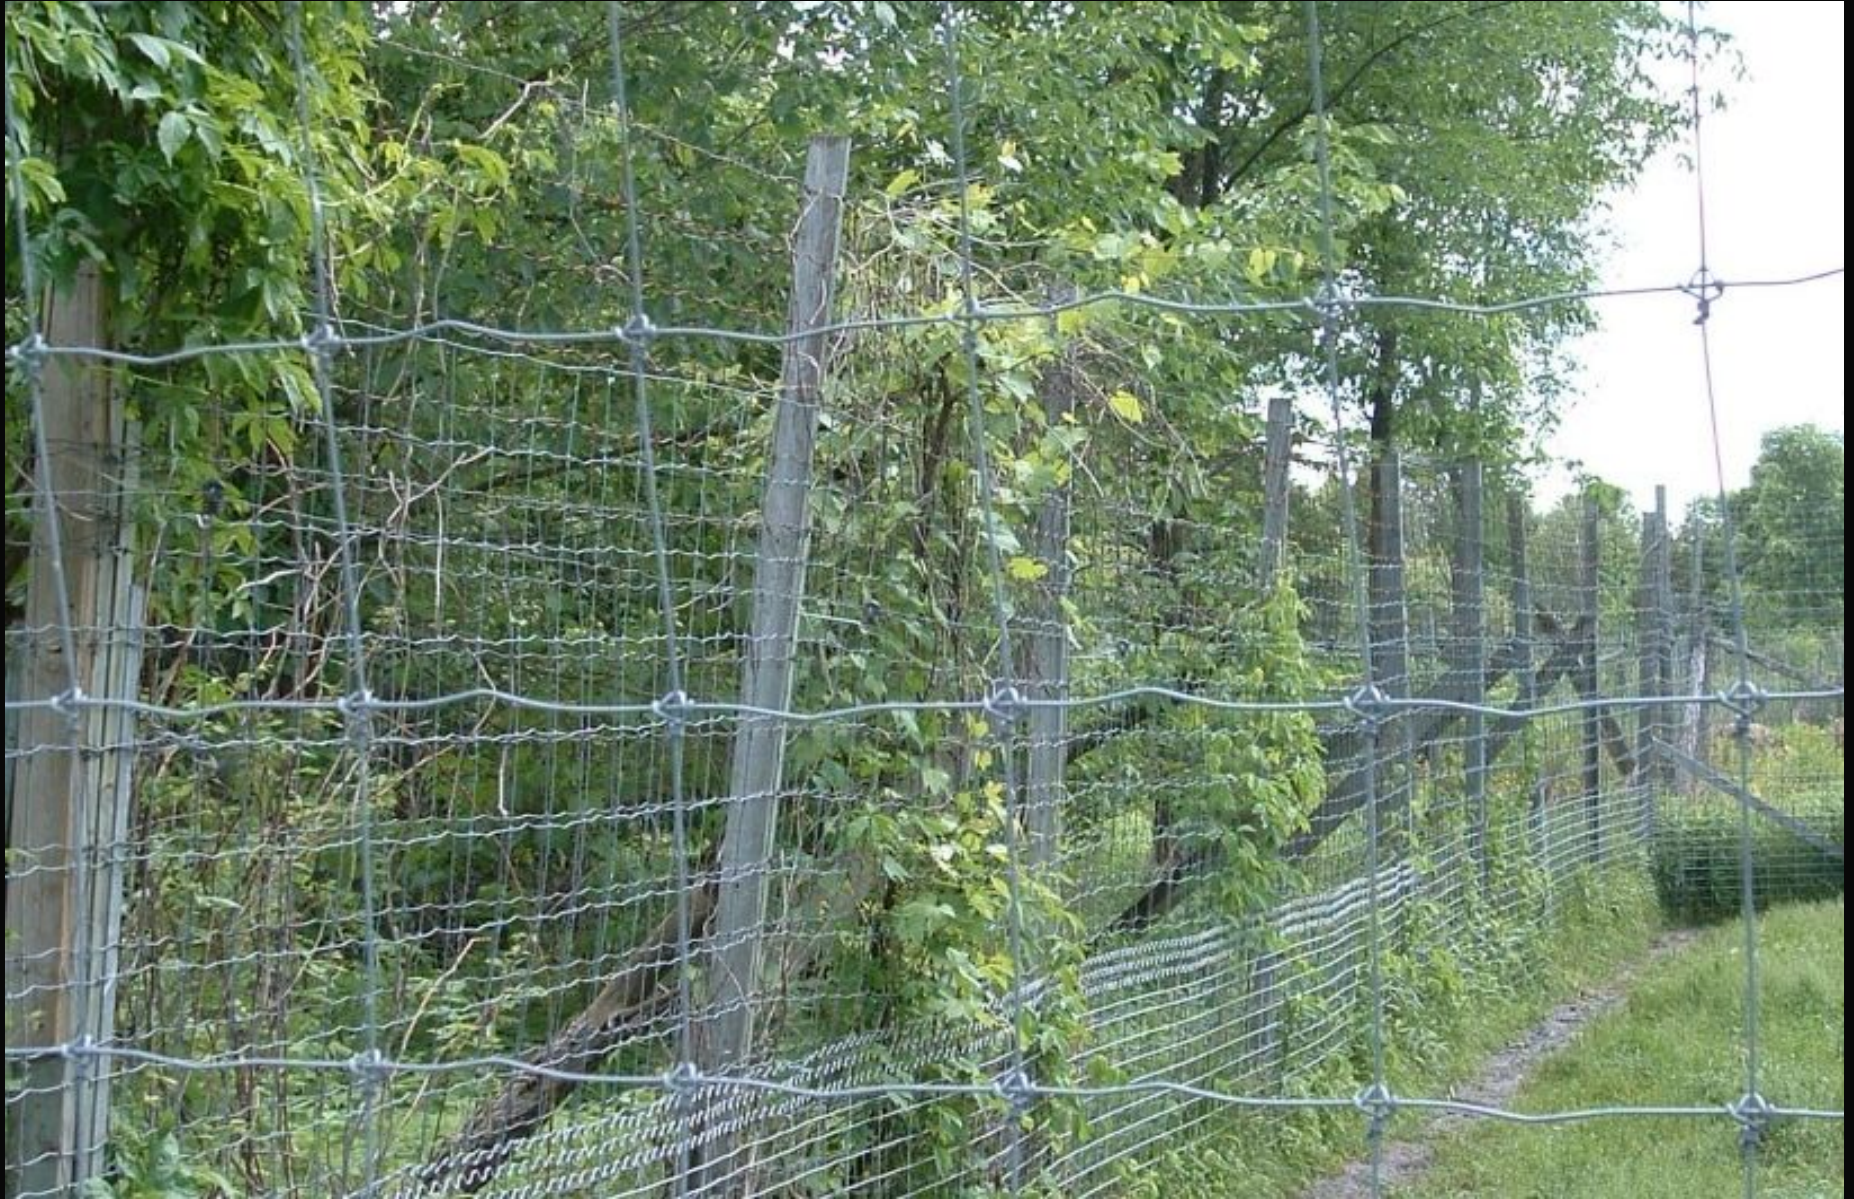
Tiger enclosure barrier lower at side and back of exhibit. Mishmash of materials used. No overhang to discourage jumping. Trees near fenceline. – Elmvale Jungle Zoo 2010

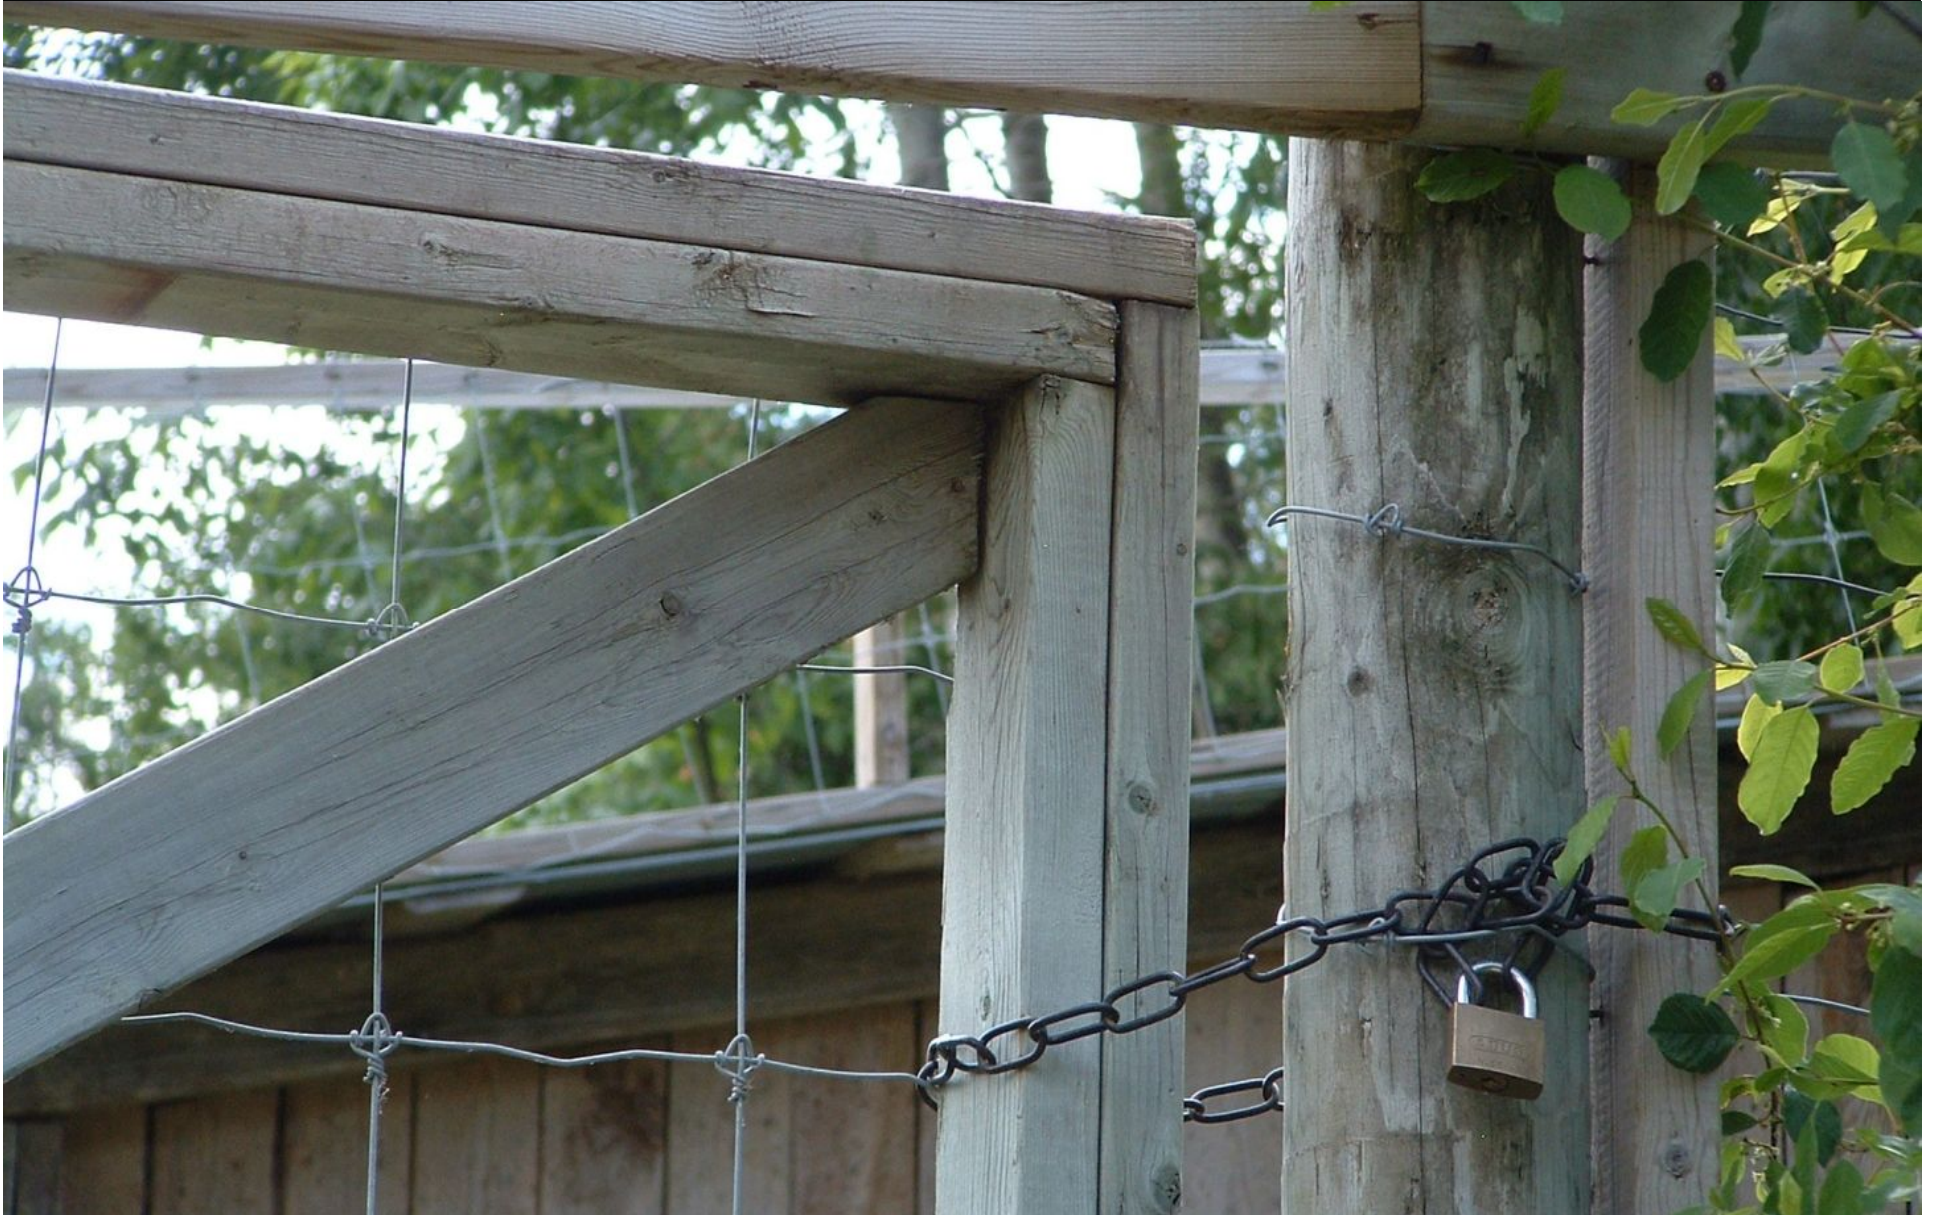
Gate into tiger enclosure does not fit properly into frame leaving substantial gaps. Gate secured with chain and small padlock. – Elmvale Jungle Zoo 2010

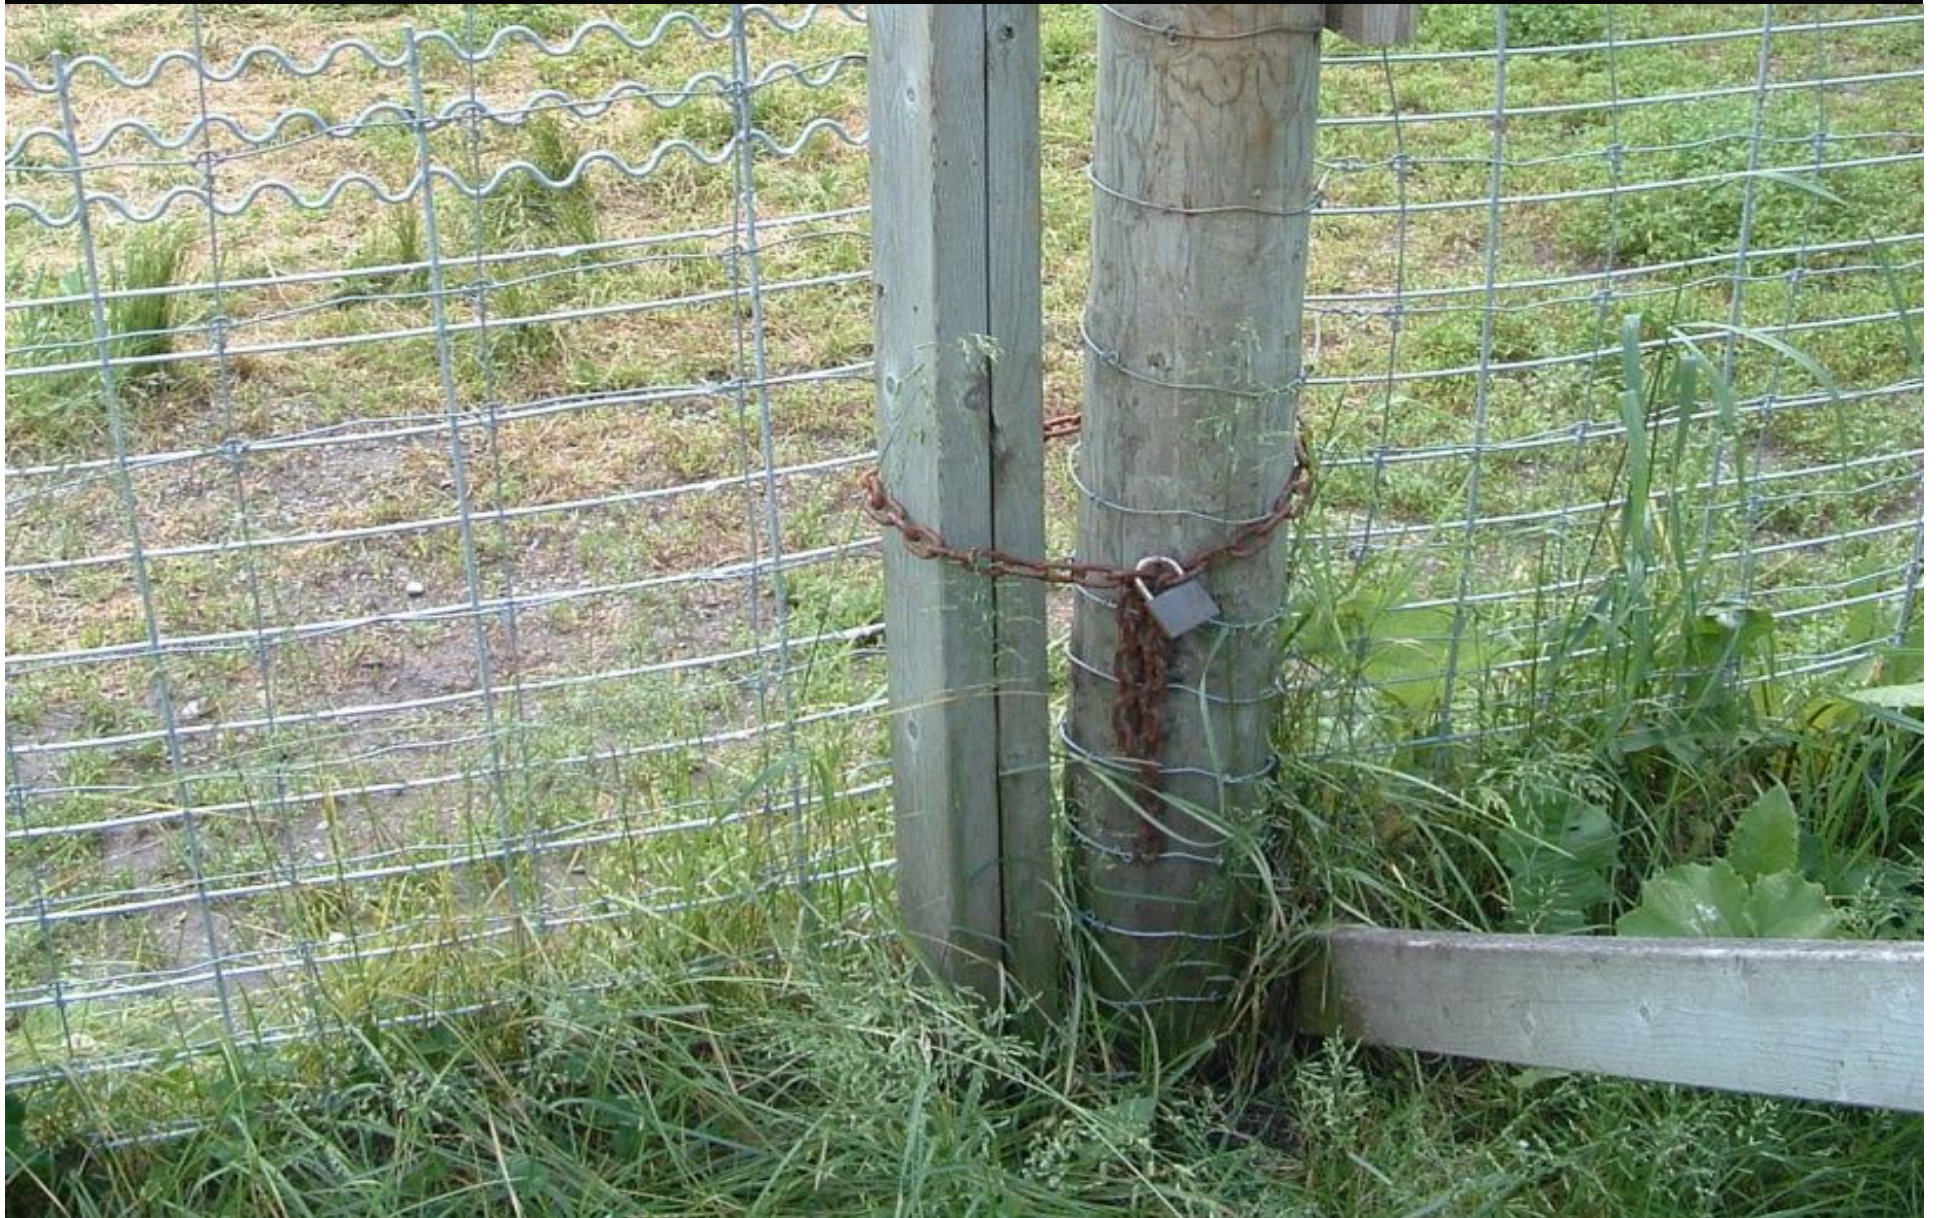
Close up of lower portion of gate into tiger enclosure secured by chain and small padlock. –  
Elmvale Jungle Zoo 2010

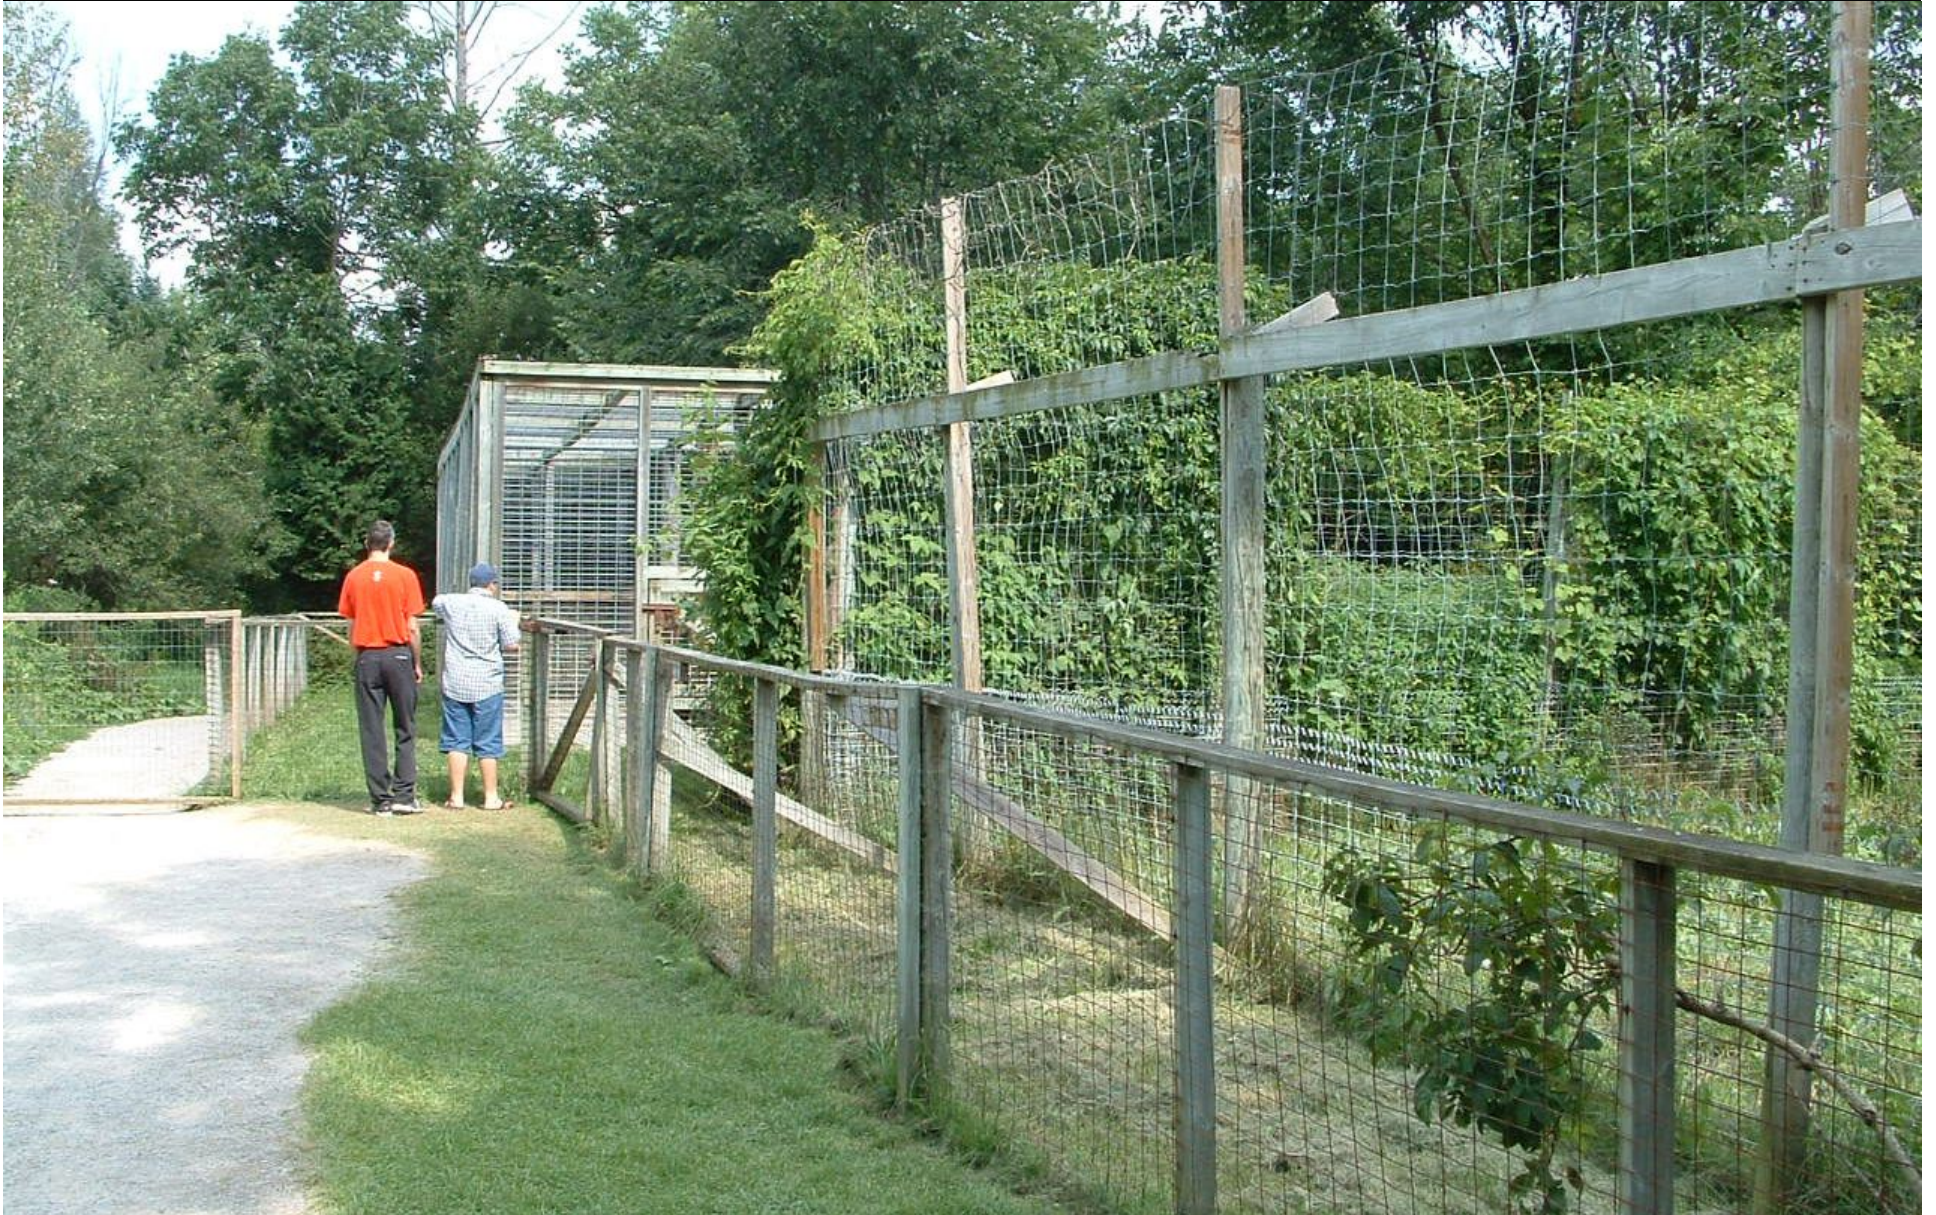
Two dead-end pathways were close to the tiger enclosure creating a potential for visitors to be trapped in event of an escape. – Elmvale Jungle Zoo 2010

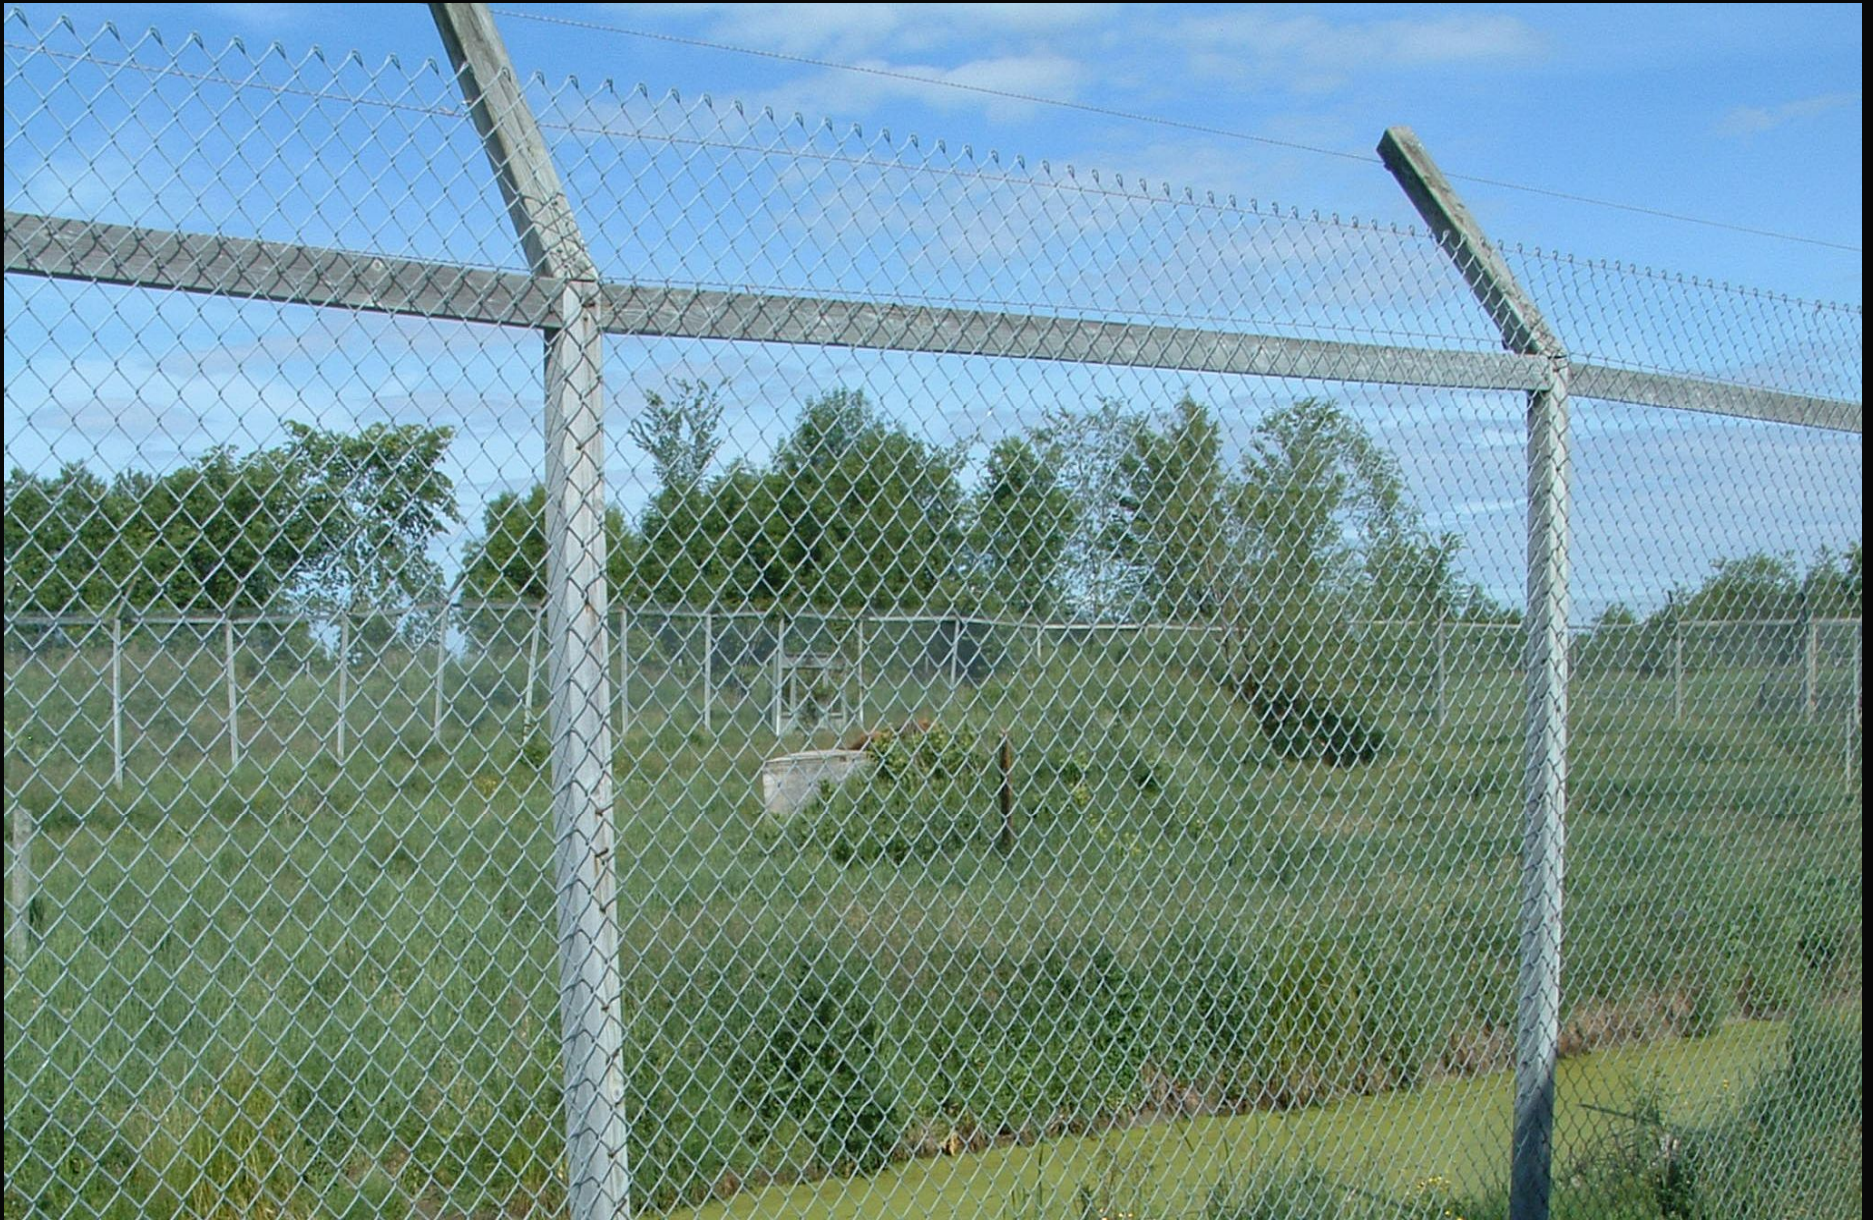
Lion enclosure fencing attached to outside of wooden support struts. Mid-level horizontal struts could be used to reinforce primary barrier struts. - Papanack Park Zoo 2010
