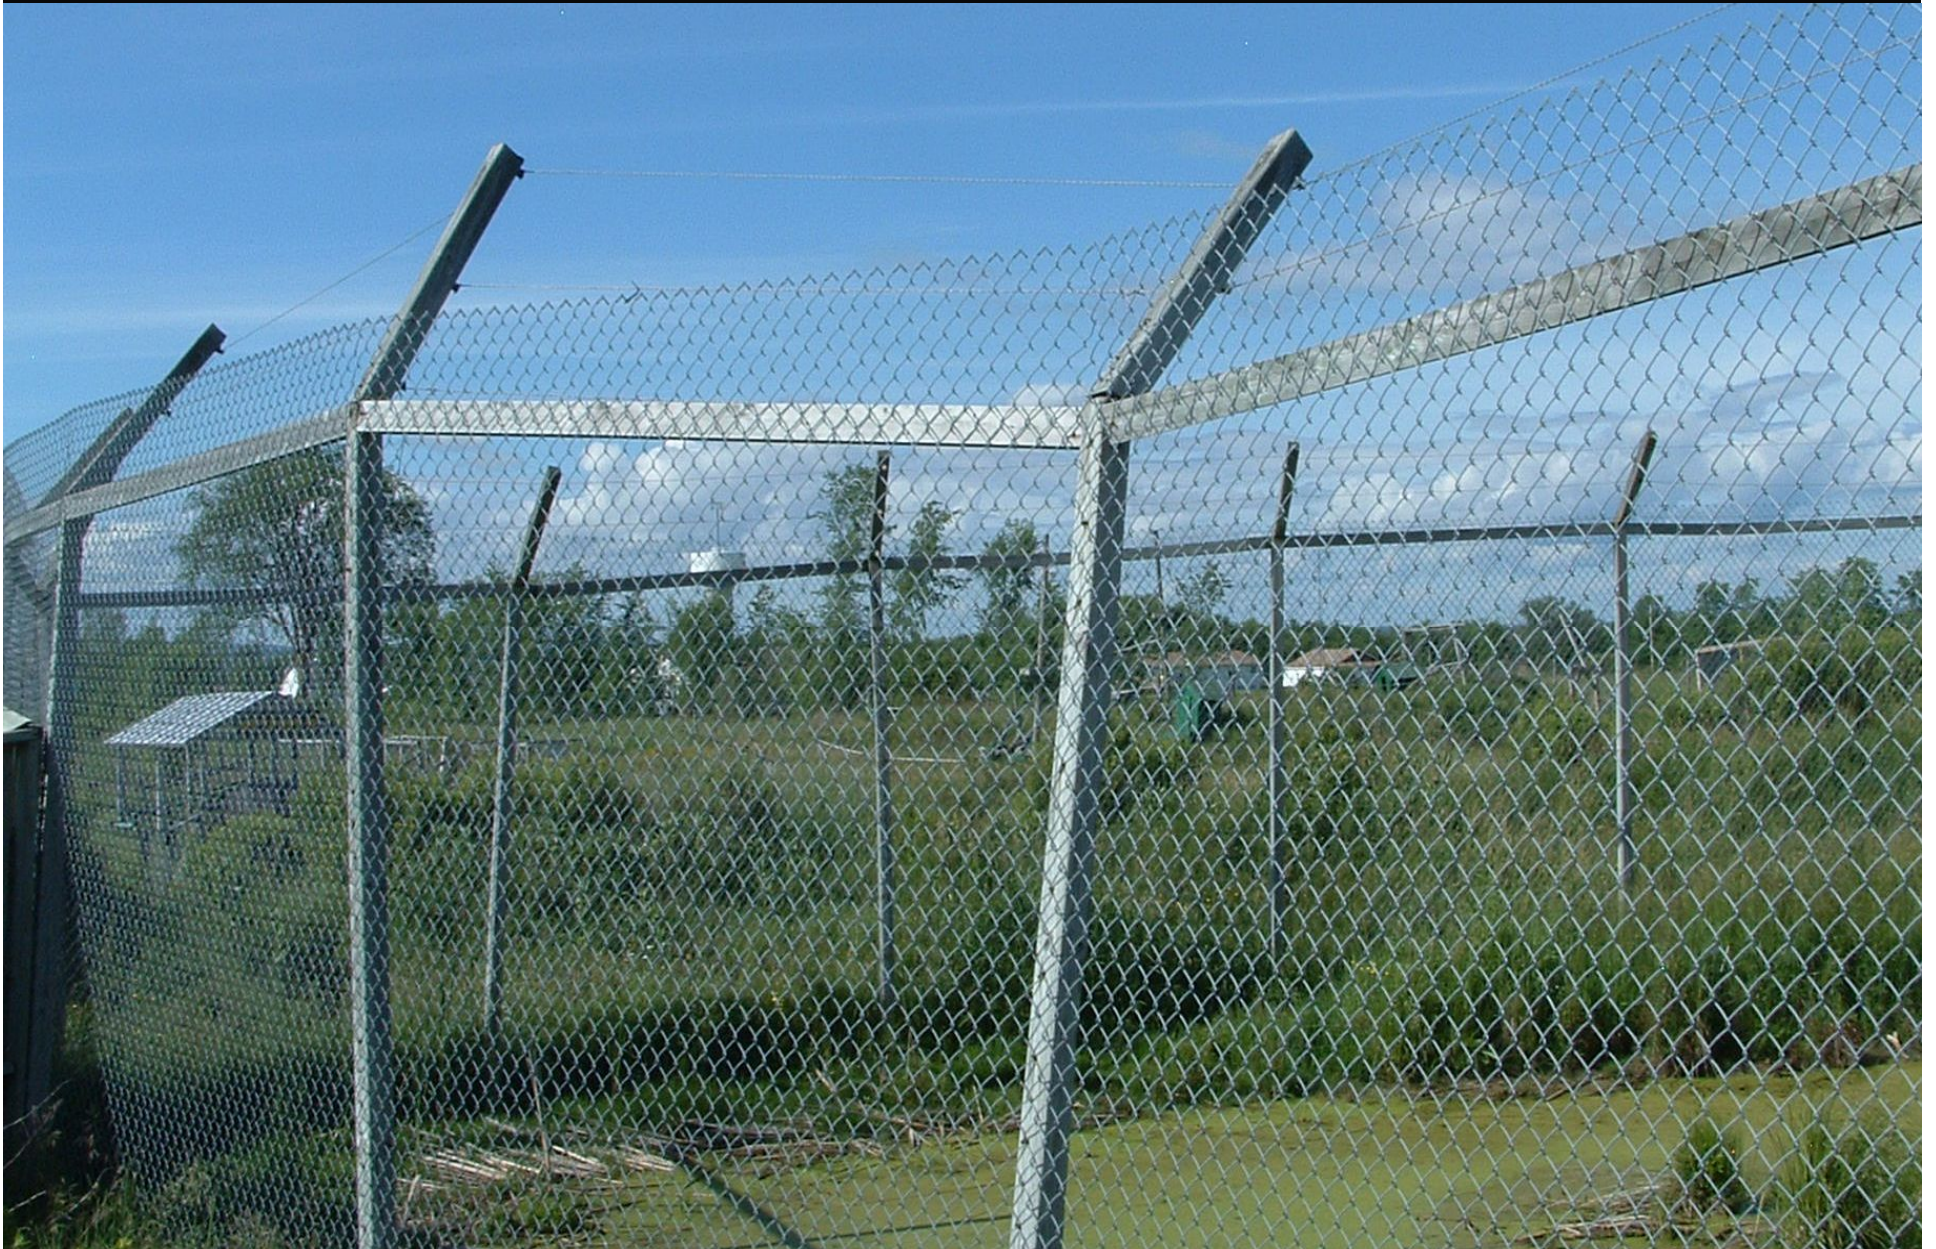
Several support posts for lion enclosure fence appear tilted. No mid-level horizontal struts for reinforcement. – Papanack Park Zoo 2010

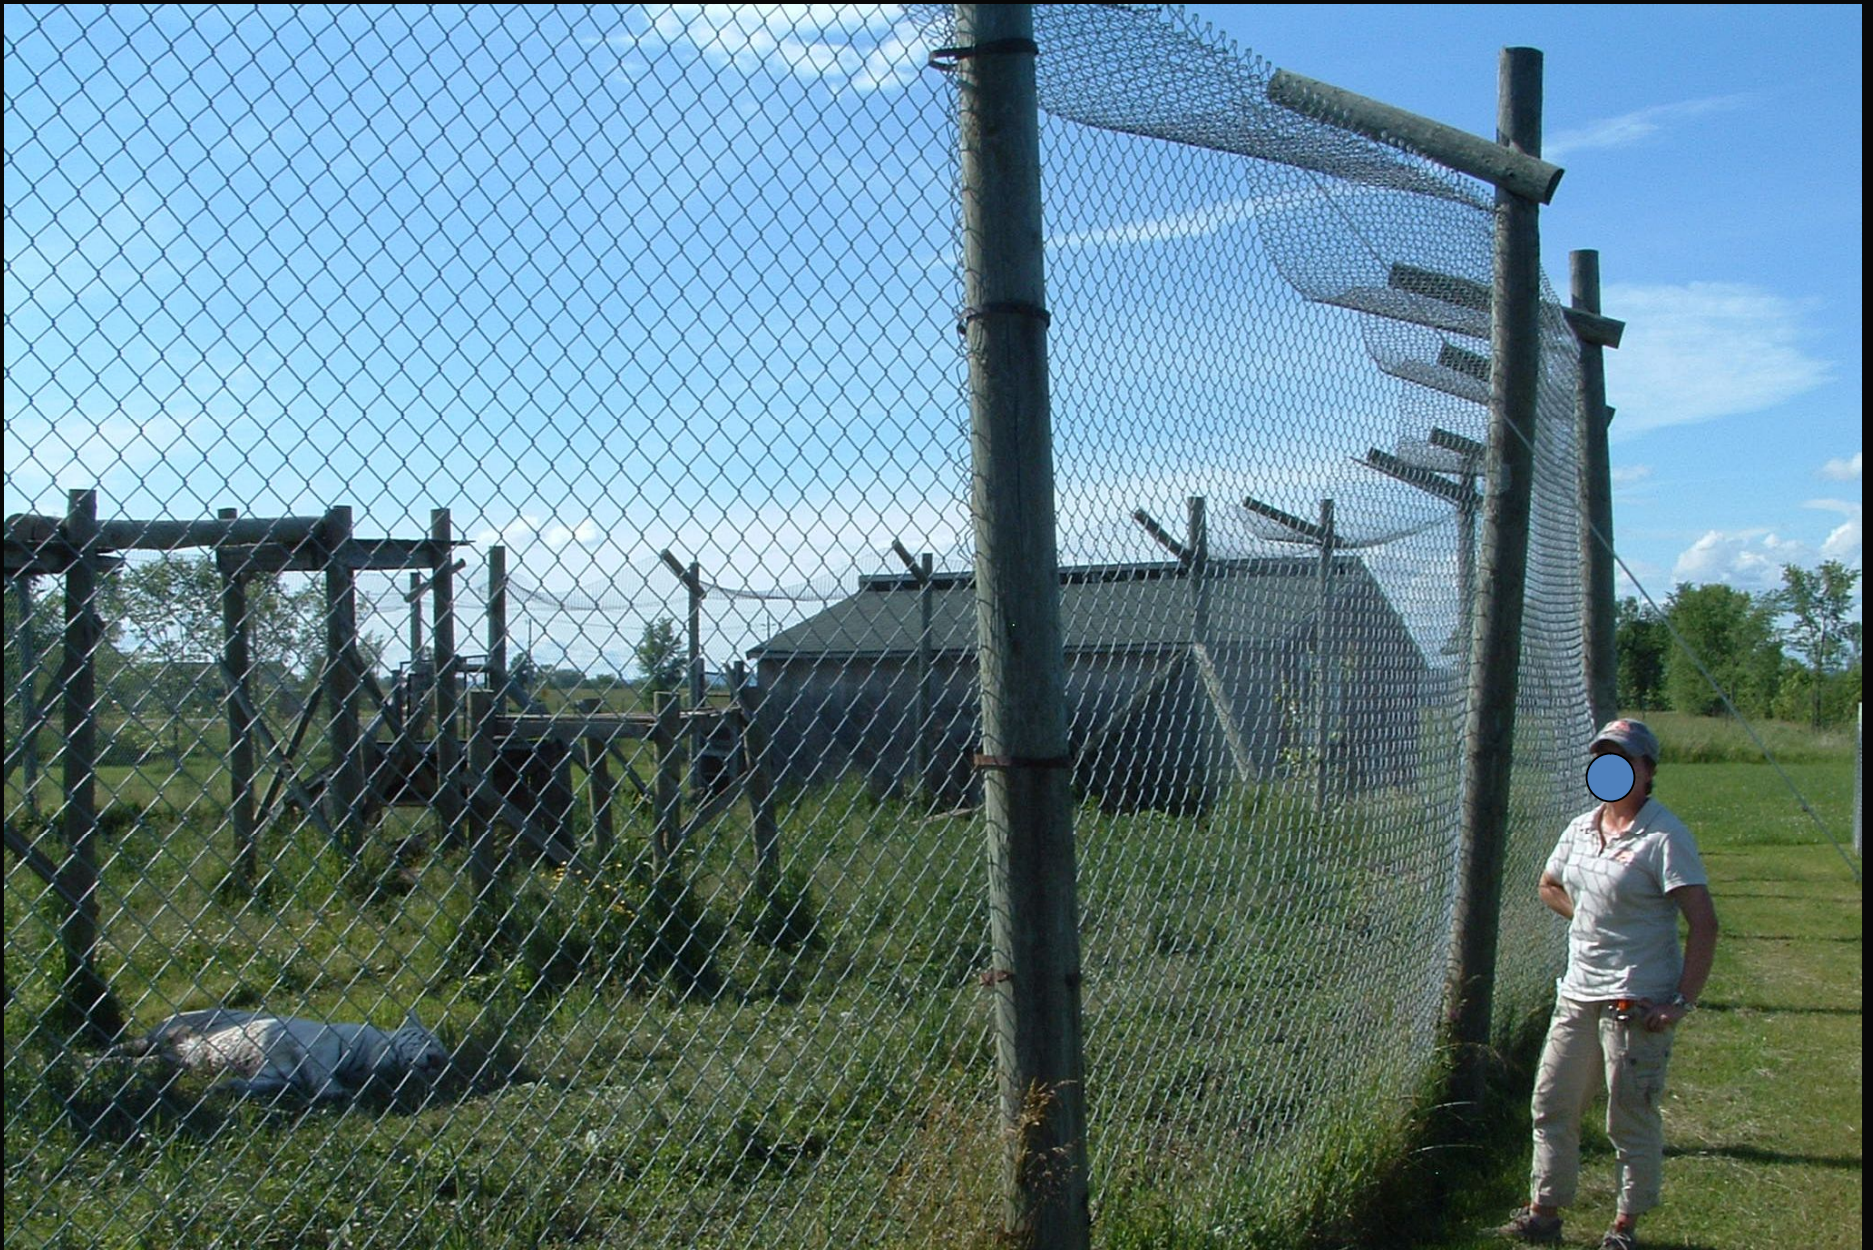
Overhang portion of white tiger enclosure barrier is sagging and appears poorly secured. Total estimated height 12 ft (3.65 m) excluding overhang. – Papanack Park Zoo 2010

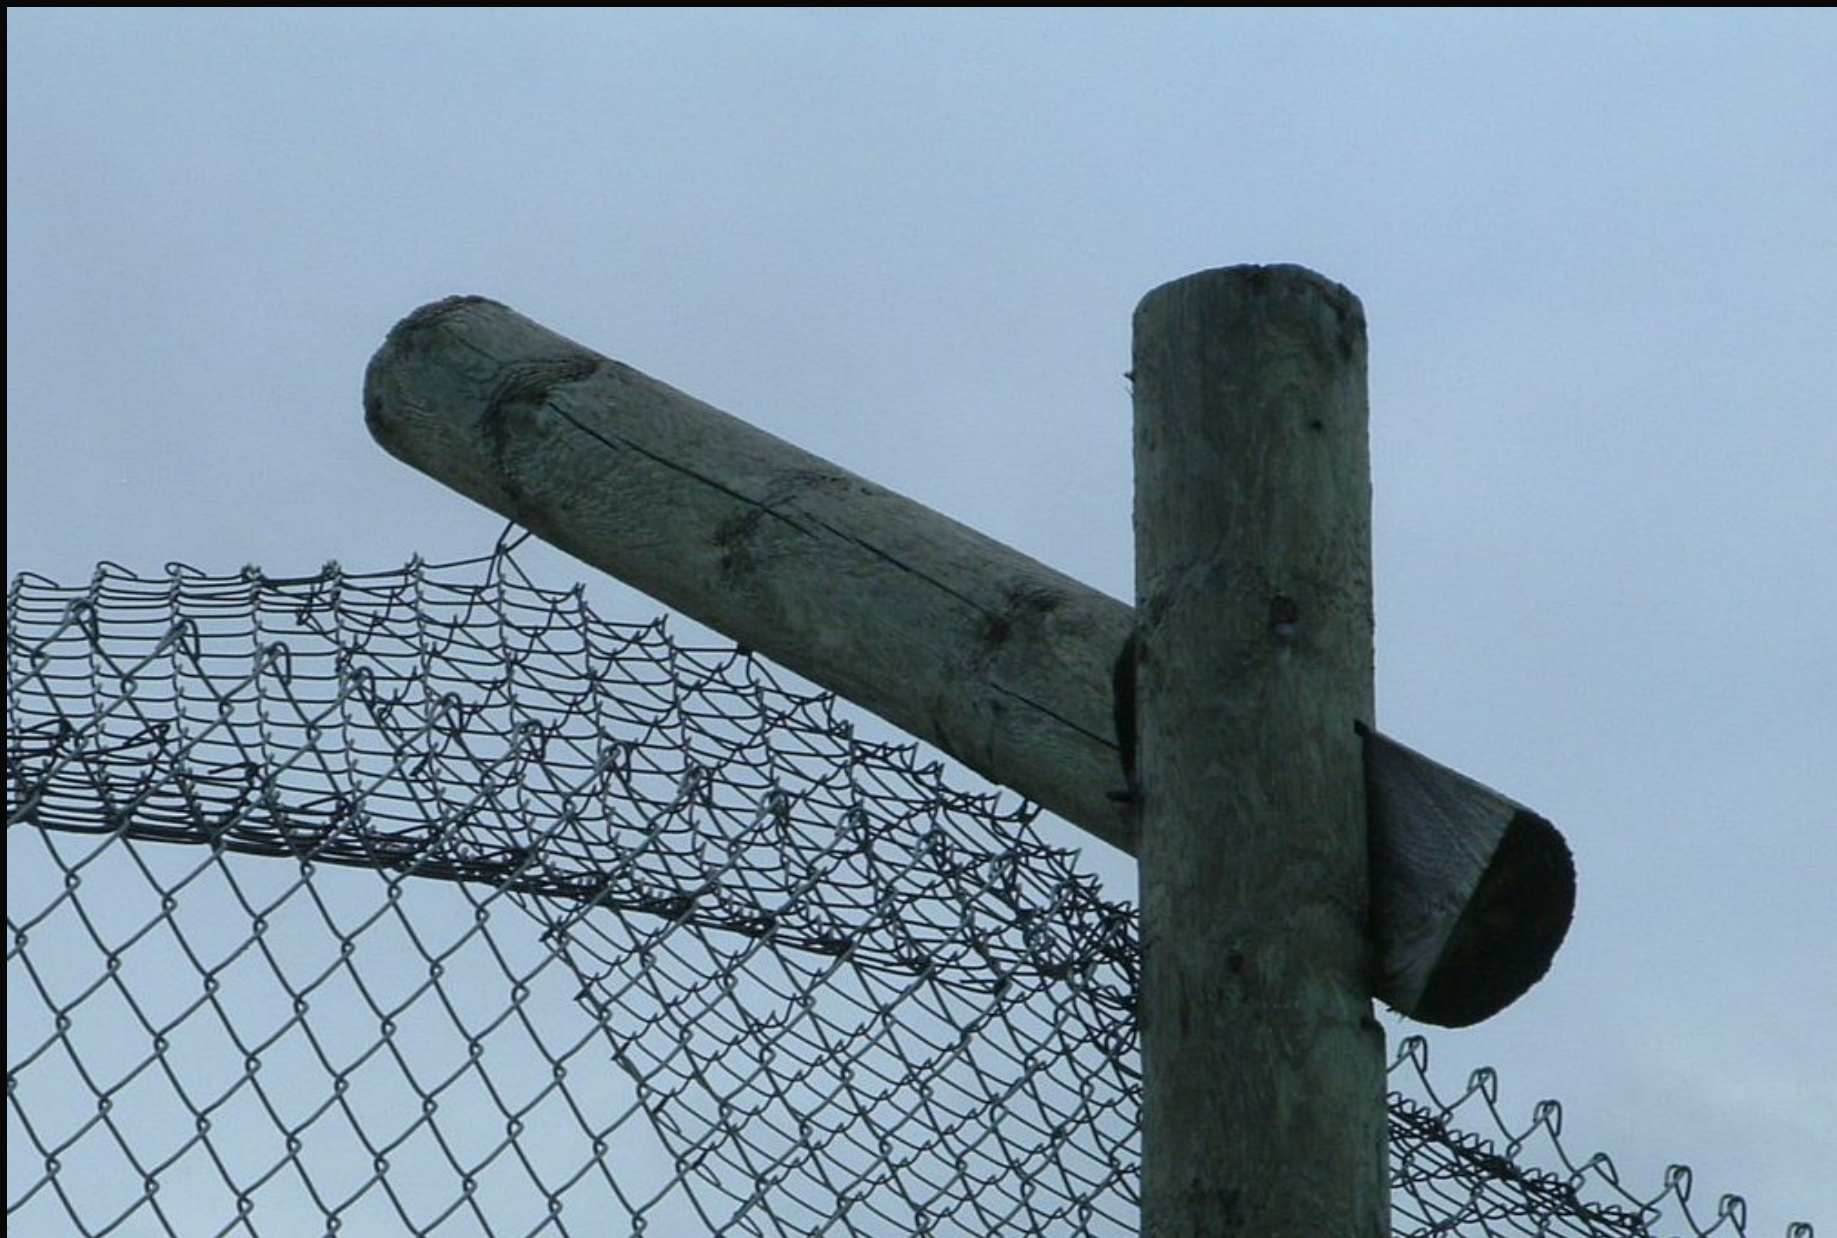
Close up of poorly secured overhang mesh and strut on white tiger enclosure. –  
Papanack Park Zoo 2010

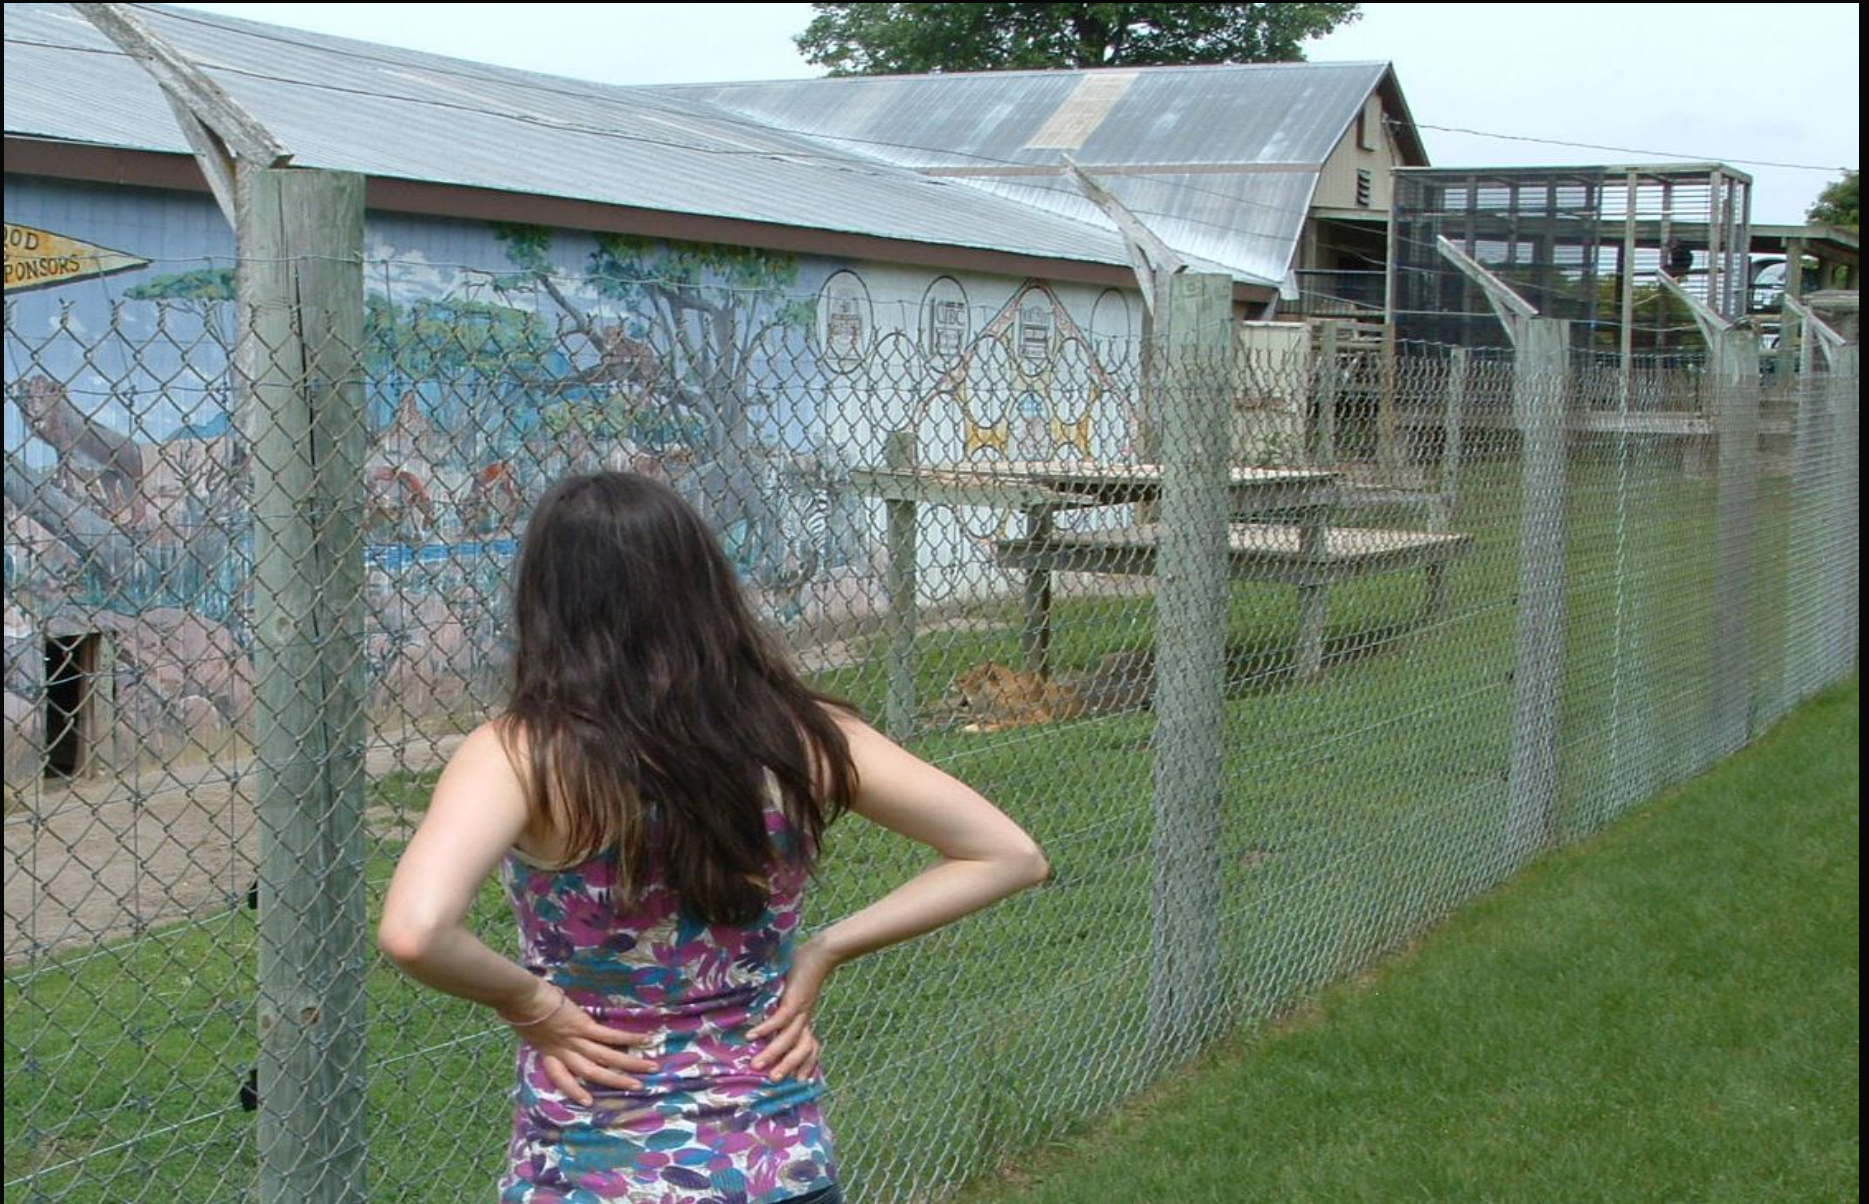
Lion enclosure barrier with estimated height of 6 ft (1.82 m), excluding hot wire overhang. No public stand-off barrier in place. – Northwood Zoo and Animal Sanctuary 2010

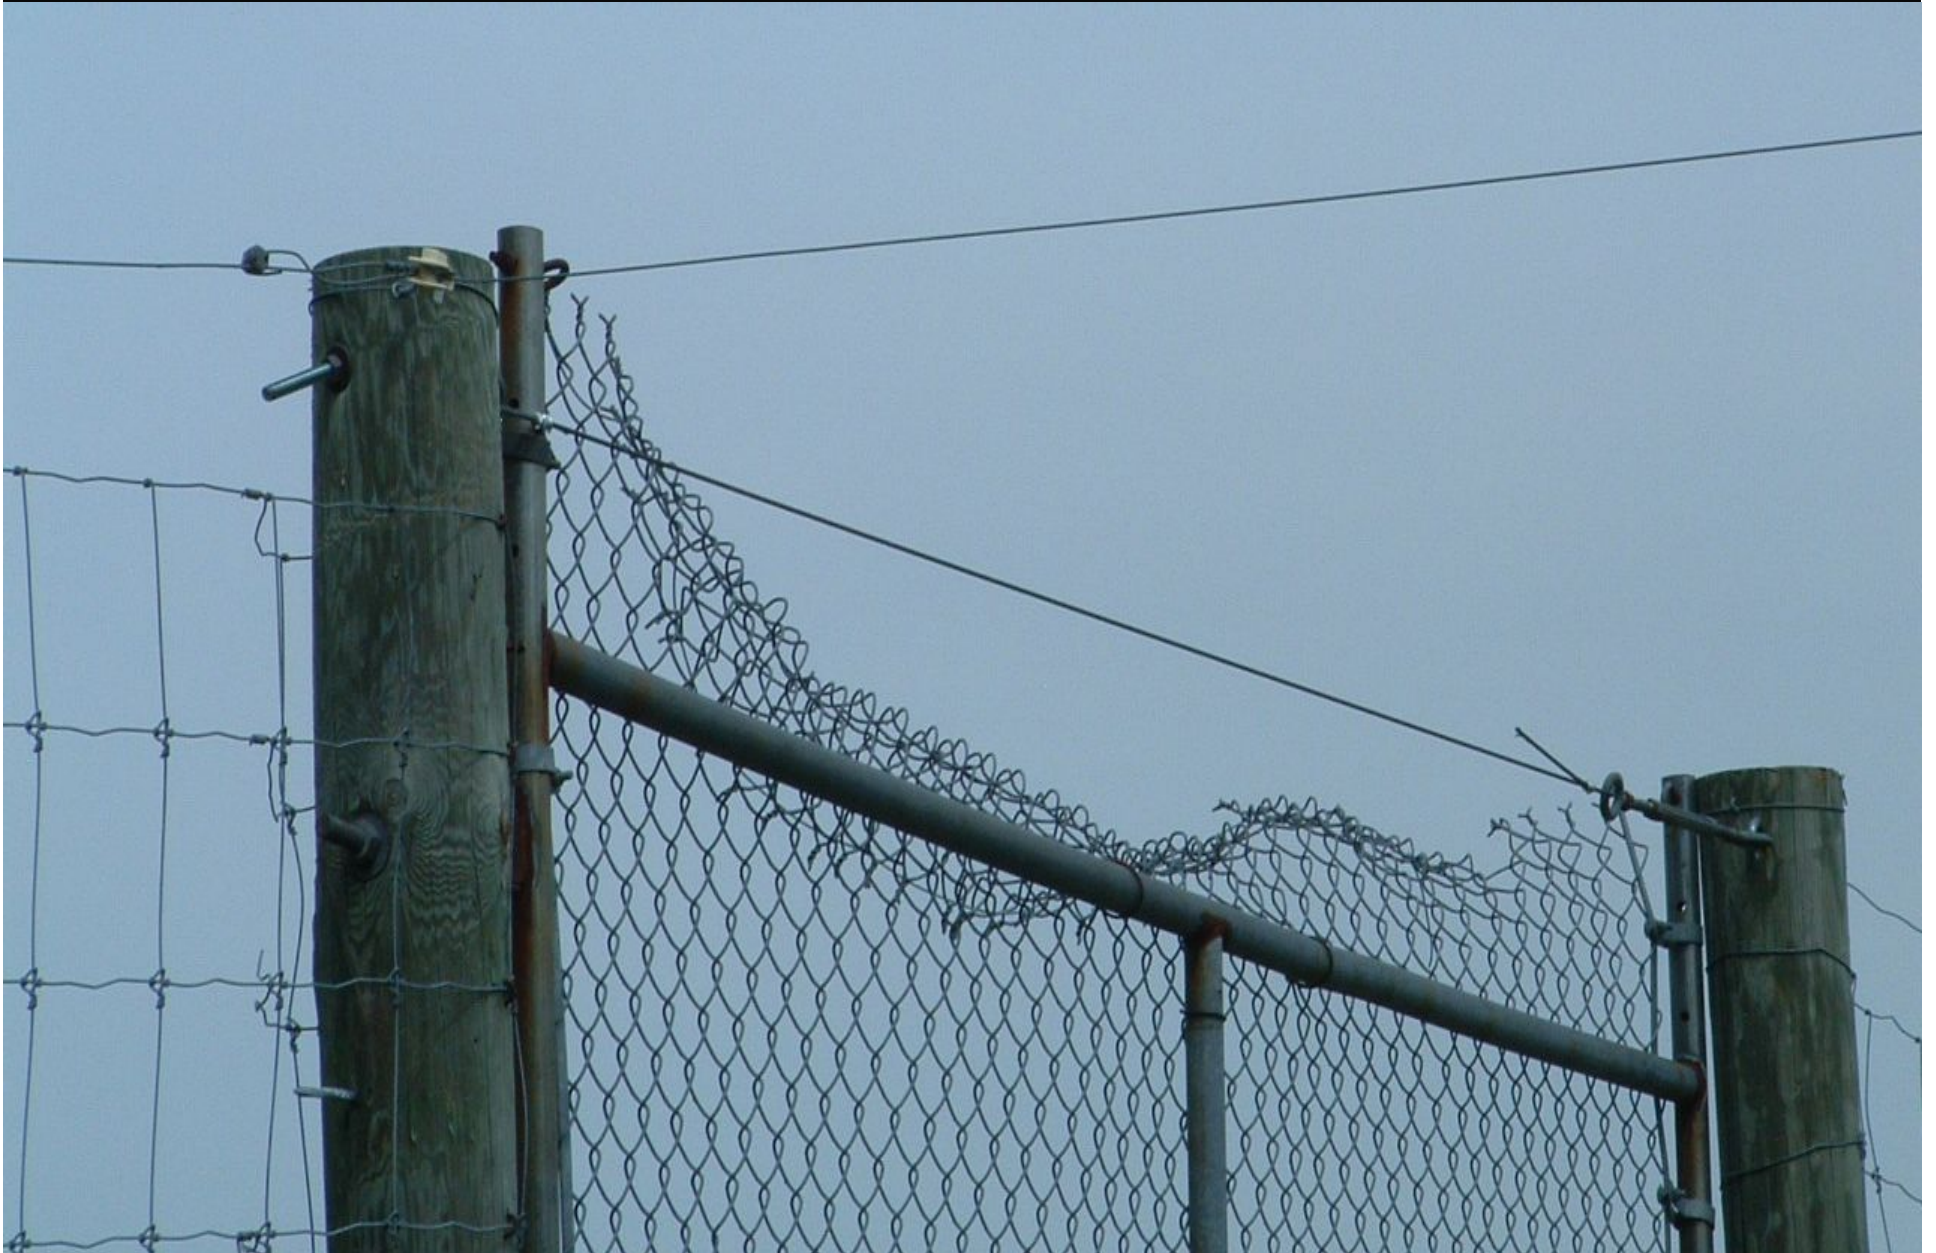
Damaged section of tiger enclosure fence. No overhang. Barrier fencing on either side is deer fence. – Northwood Zoo and Animal Sanctuary 2010

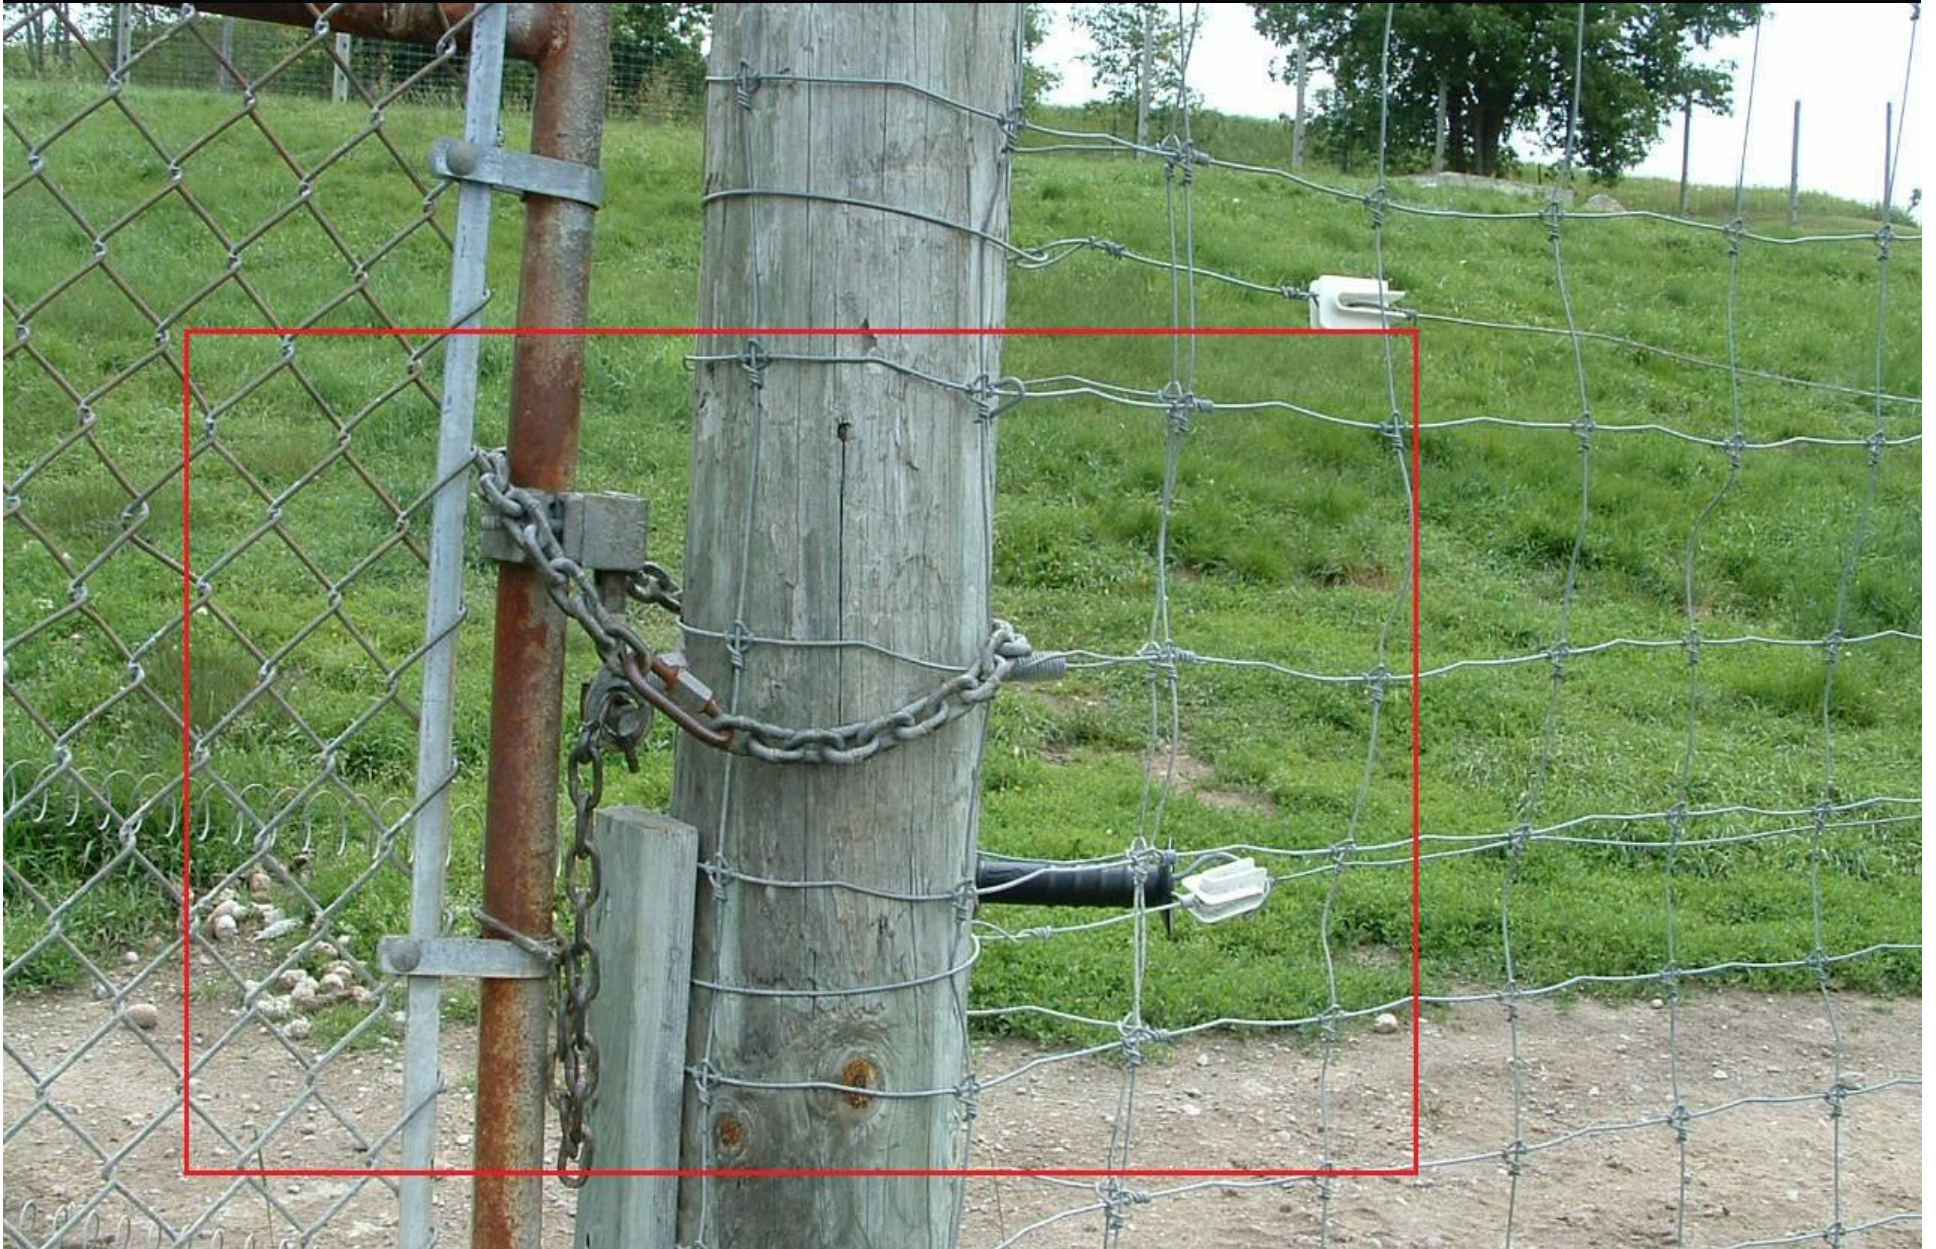
Gate into lion enclosure secured by chain and non-locking carabiner. –  
Northwood Zoo and Animal Sanctuary 2010

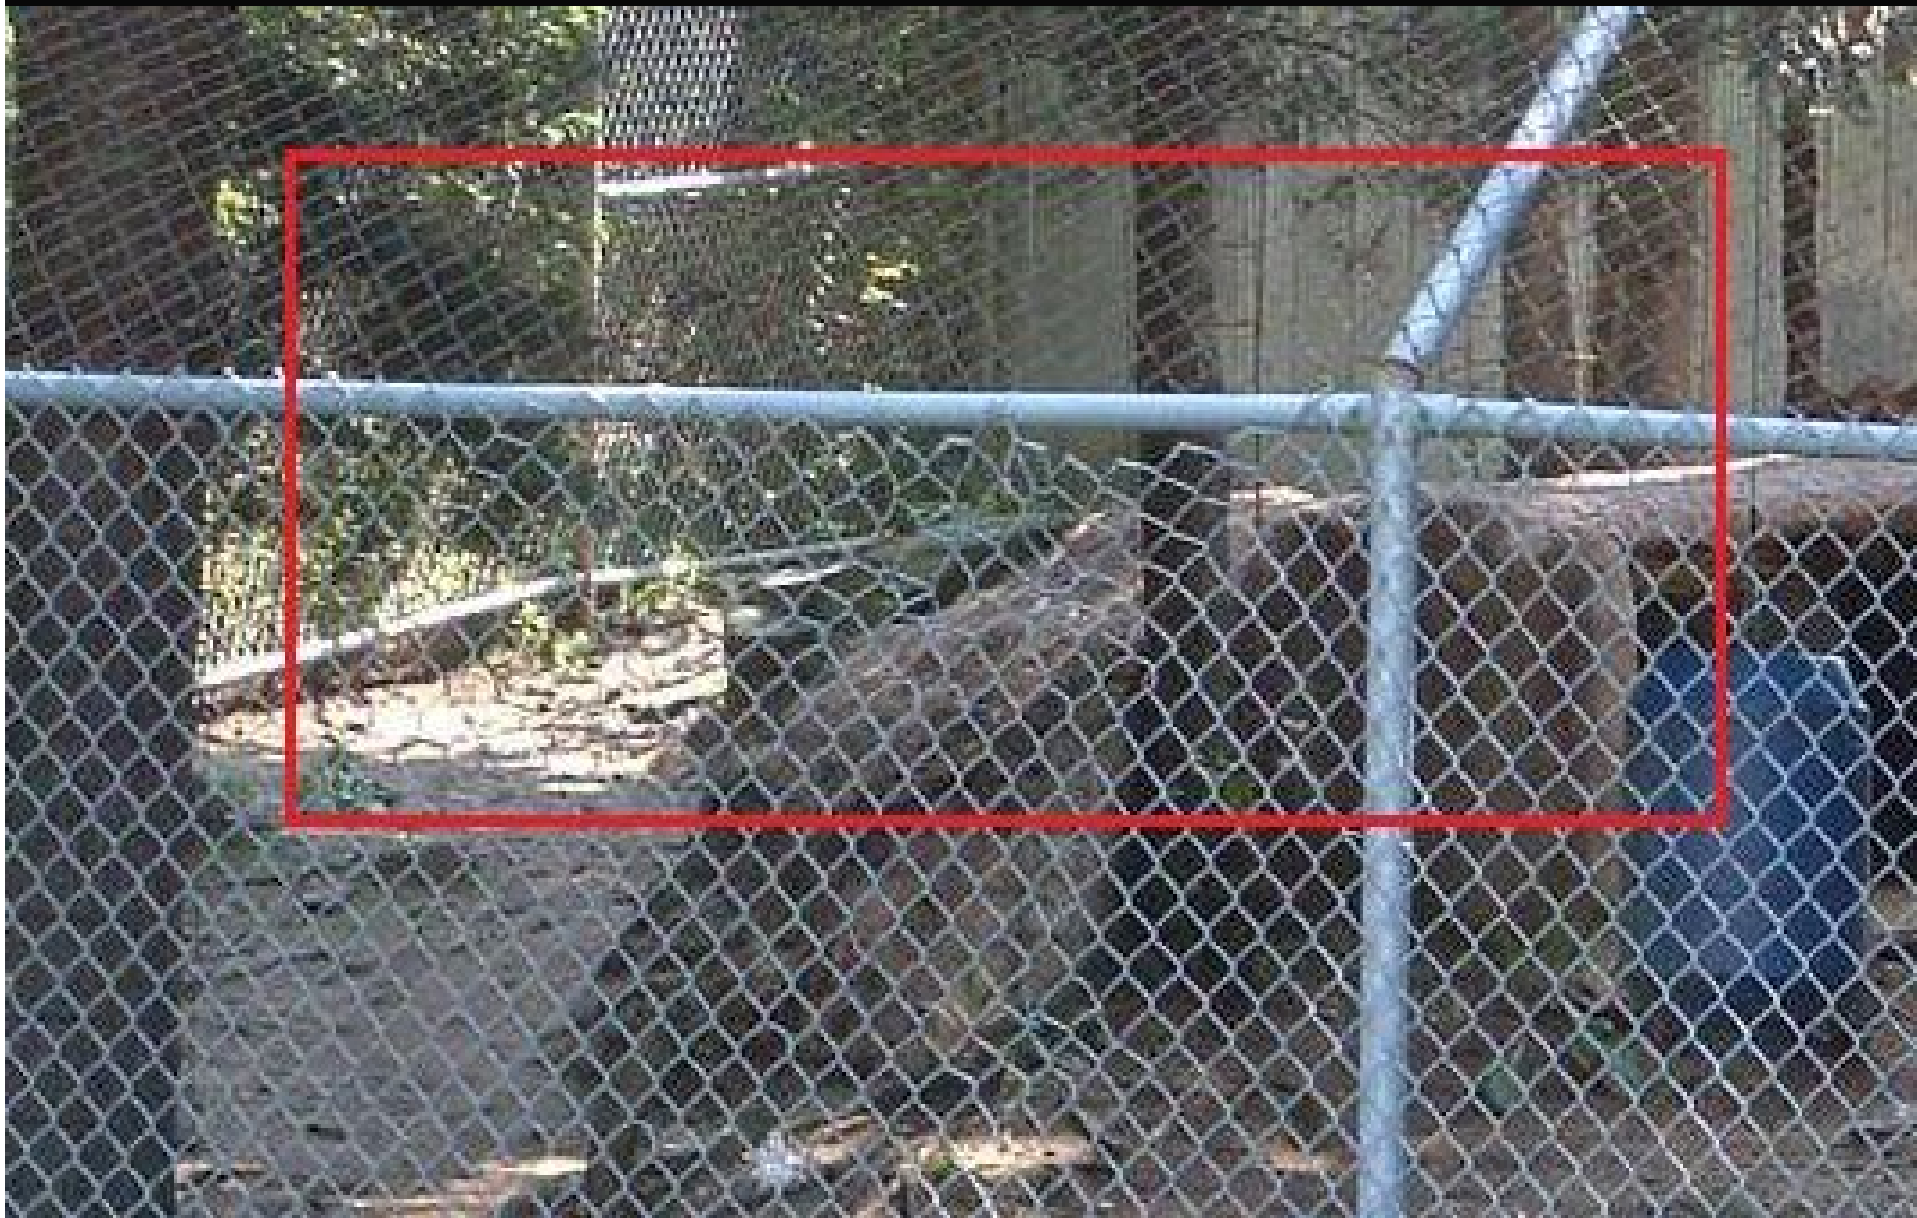
Lion enclosure barrier is damaged and in need of repair. –  
Guha's Lion and Tiger Farm 2010

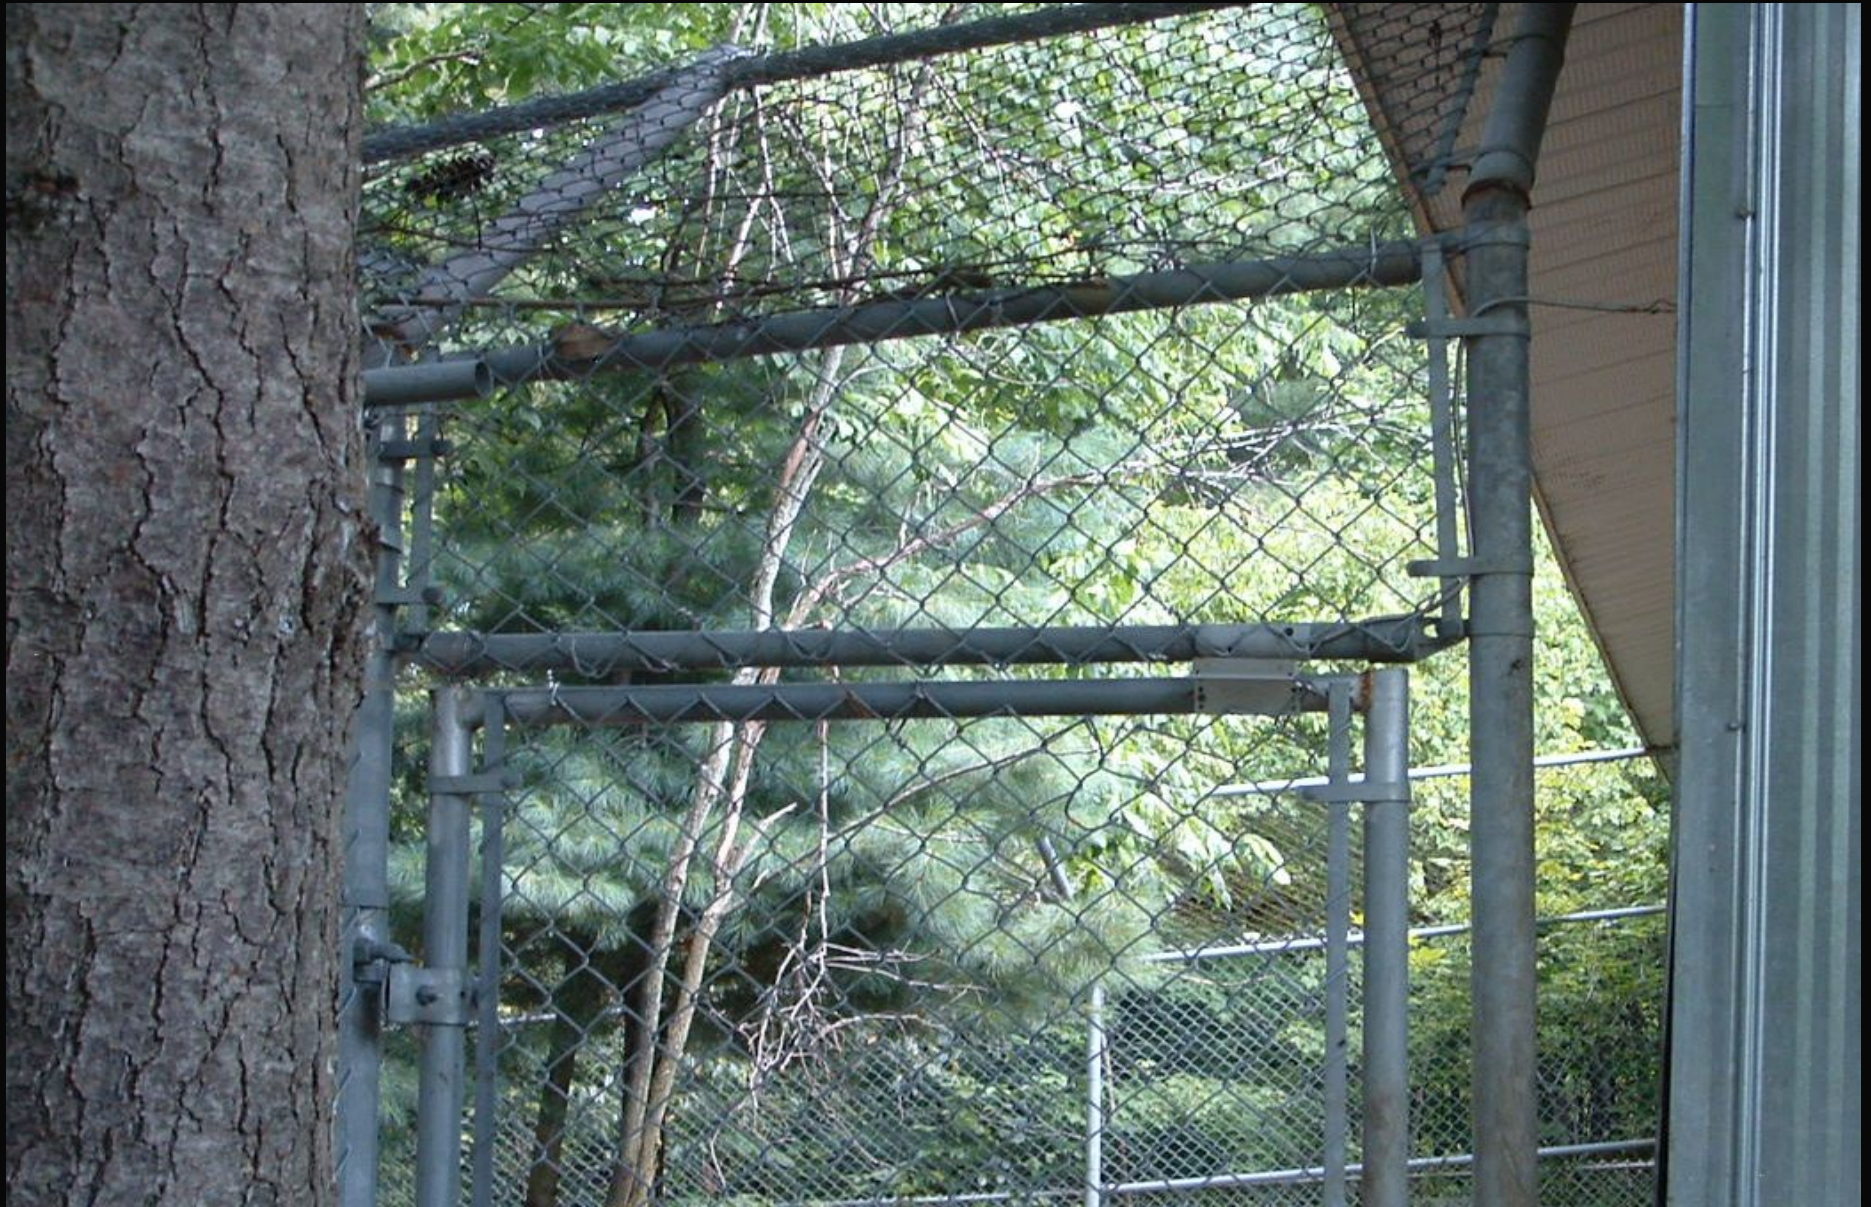
Lion enclosure has significant gap between fence barrier and service building.  
Gate doesn't fit snugly into frame. – Guha's Tiger and Lion Farm 2010

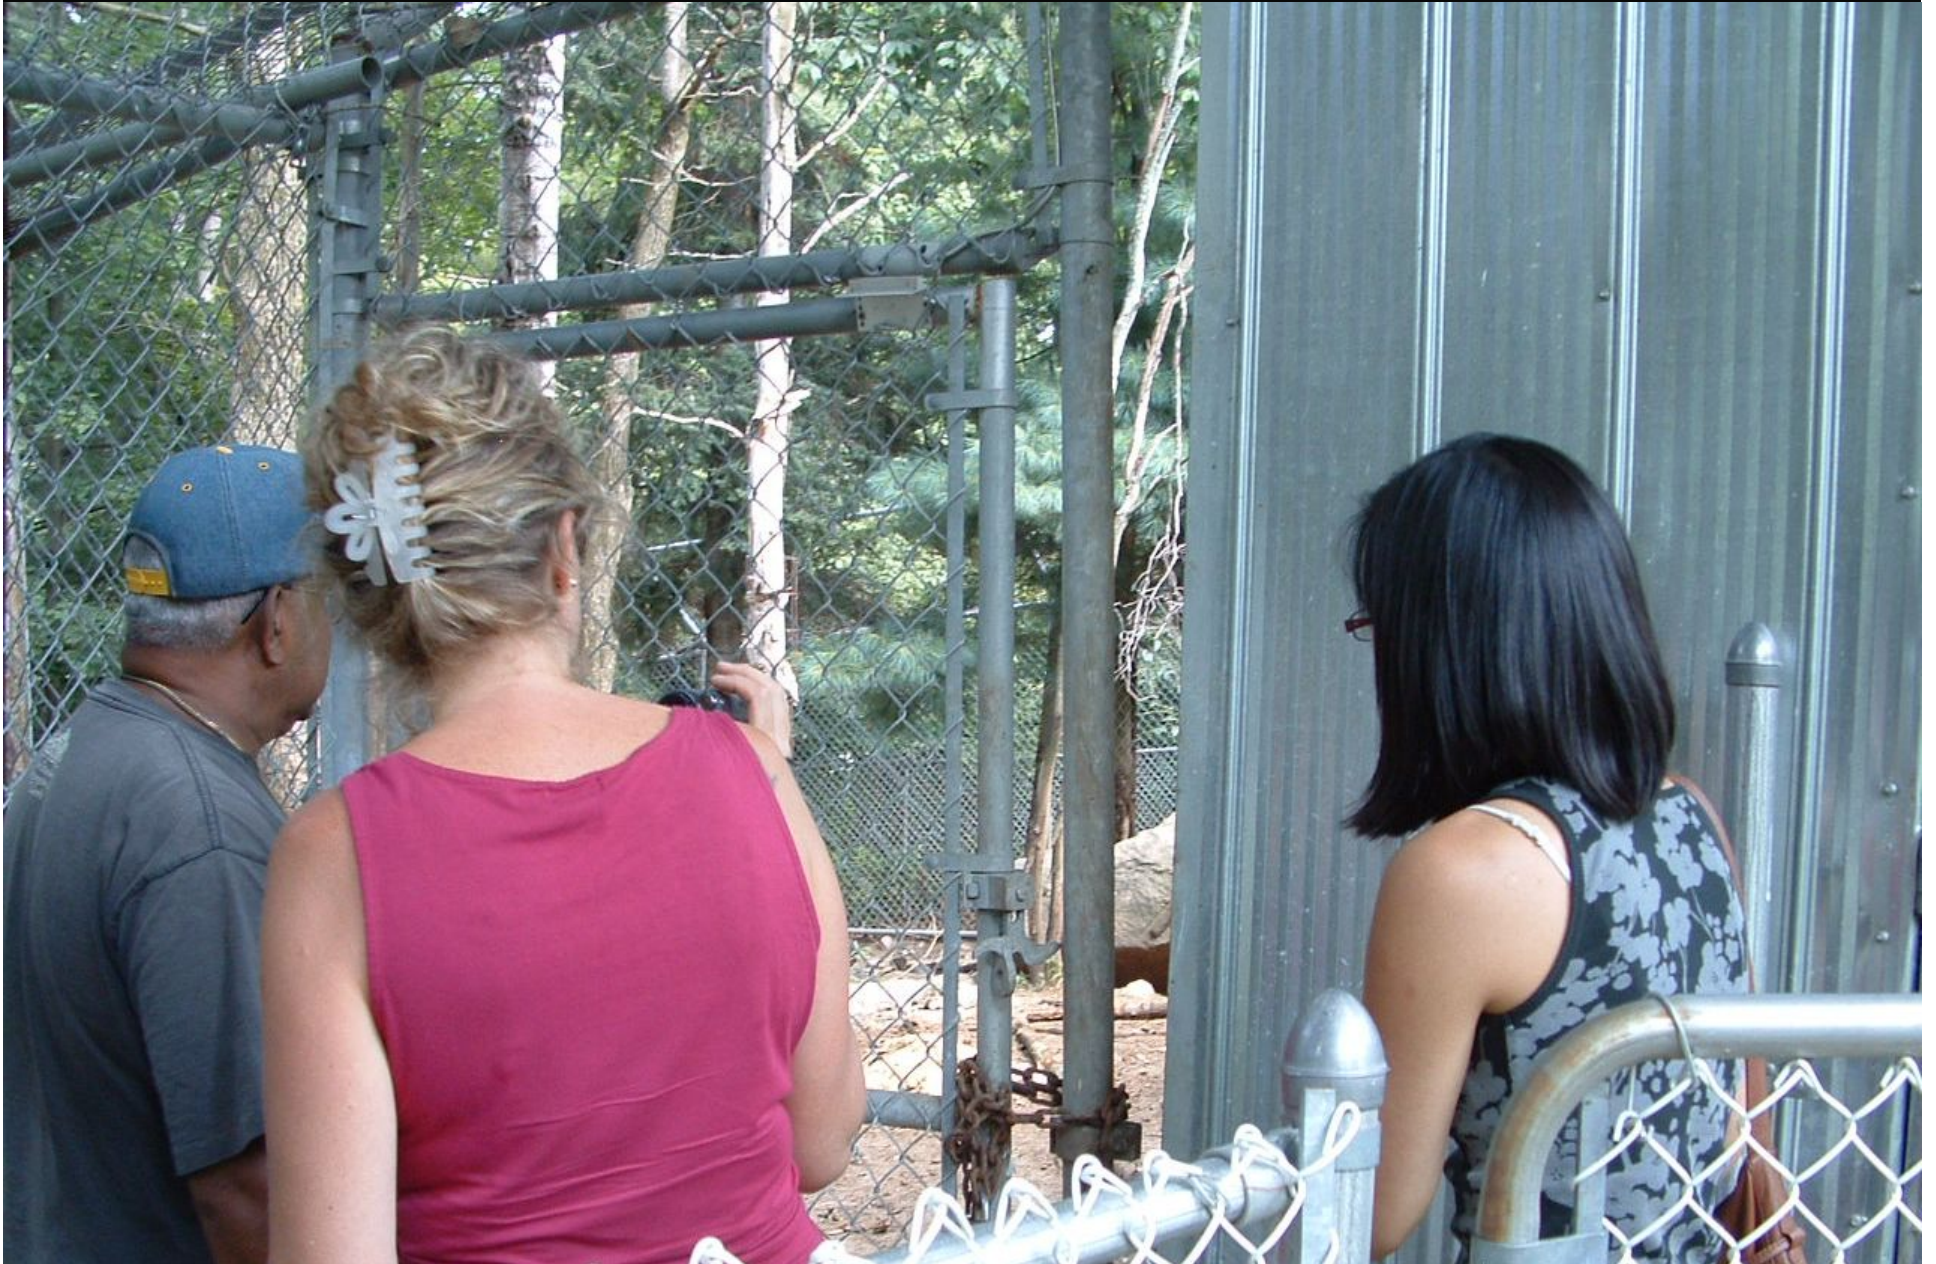
Investigators invited behind public stand-off barrier at lion enclosure. —  
Guha's Lion and Tiger Farm 2010
