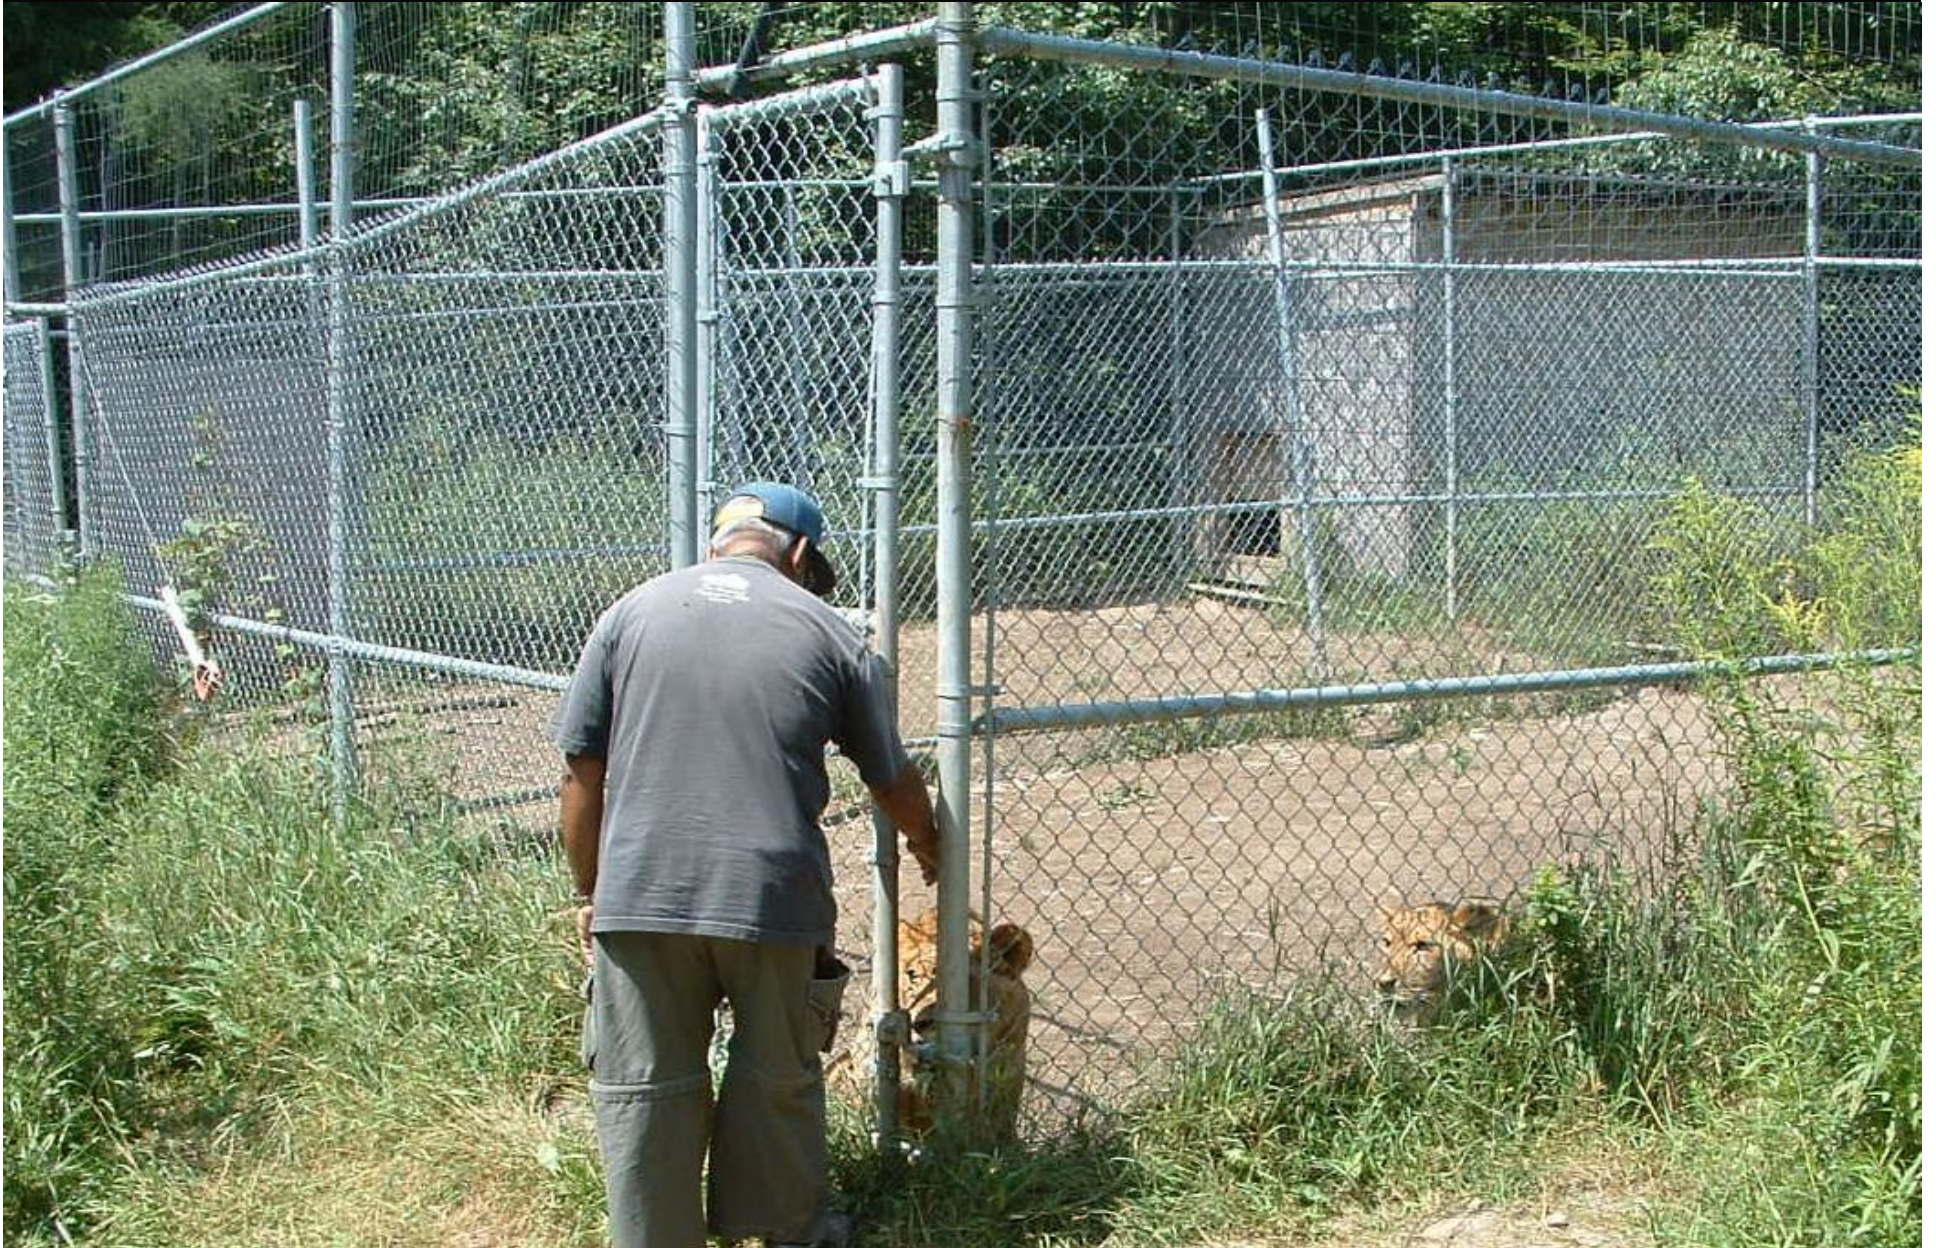
Juvenile lion enclosure barrier estimated at 12 ft (3.65 m) in height, including makeshift extension. No overhang to discourage jumping or climbing. Gates do not fit properly into frames leaving substantial gaps. No public stand-off barrier. - Guha's Lion and Tiger Farm 2010

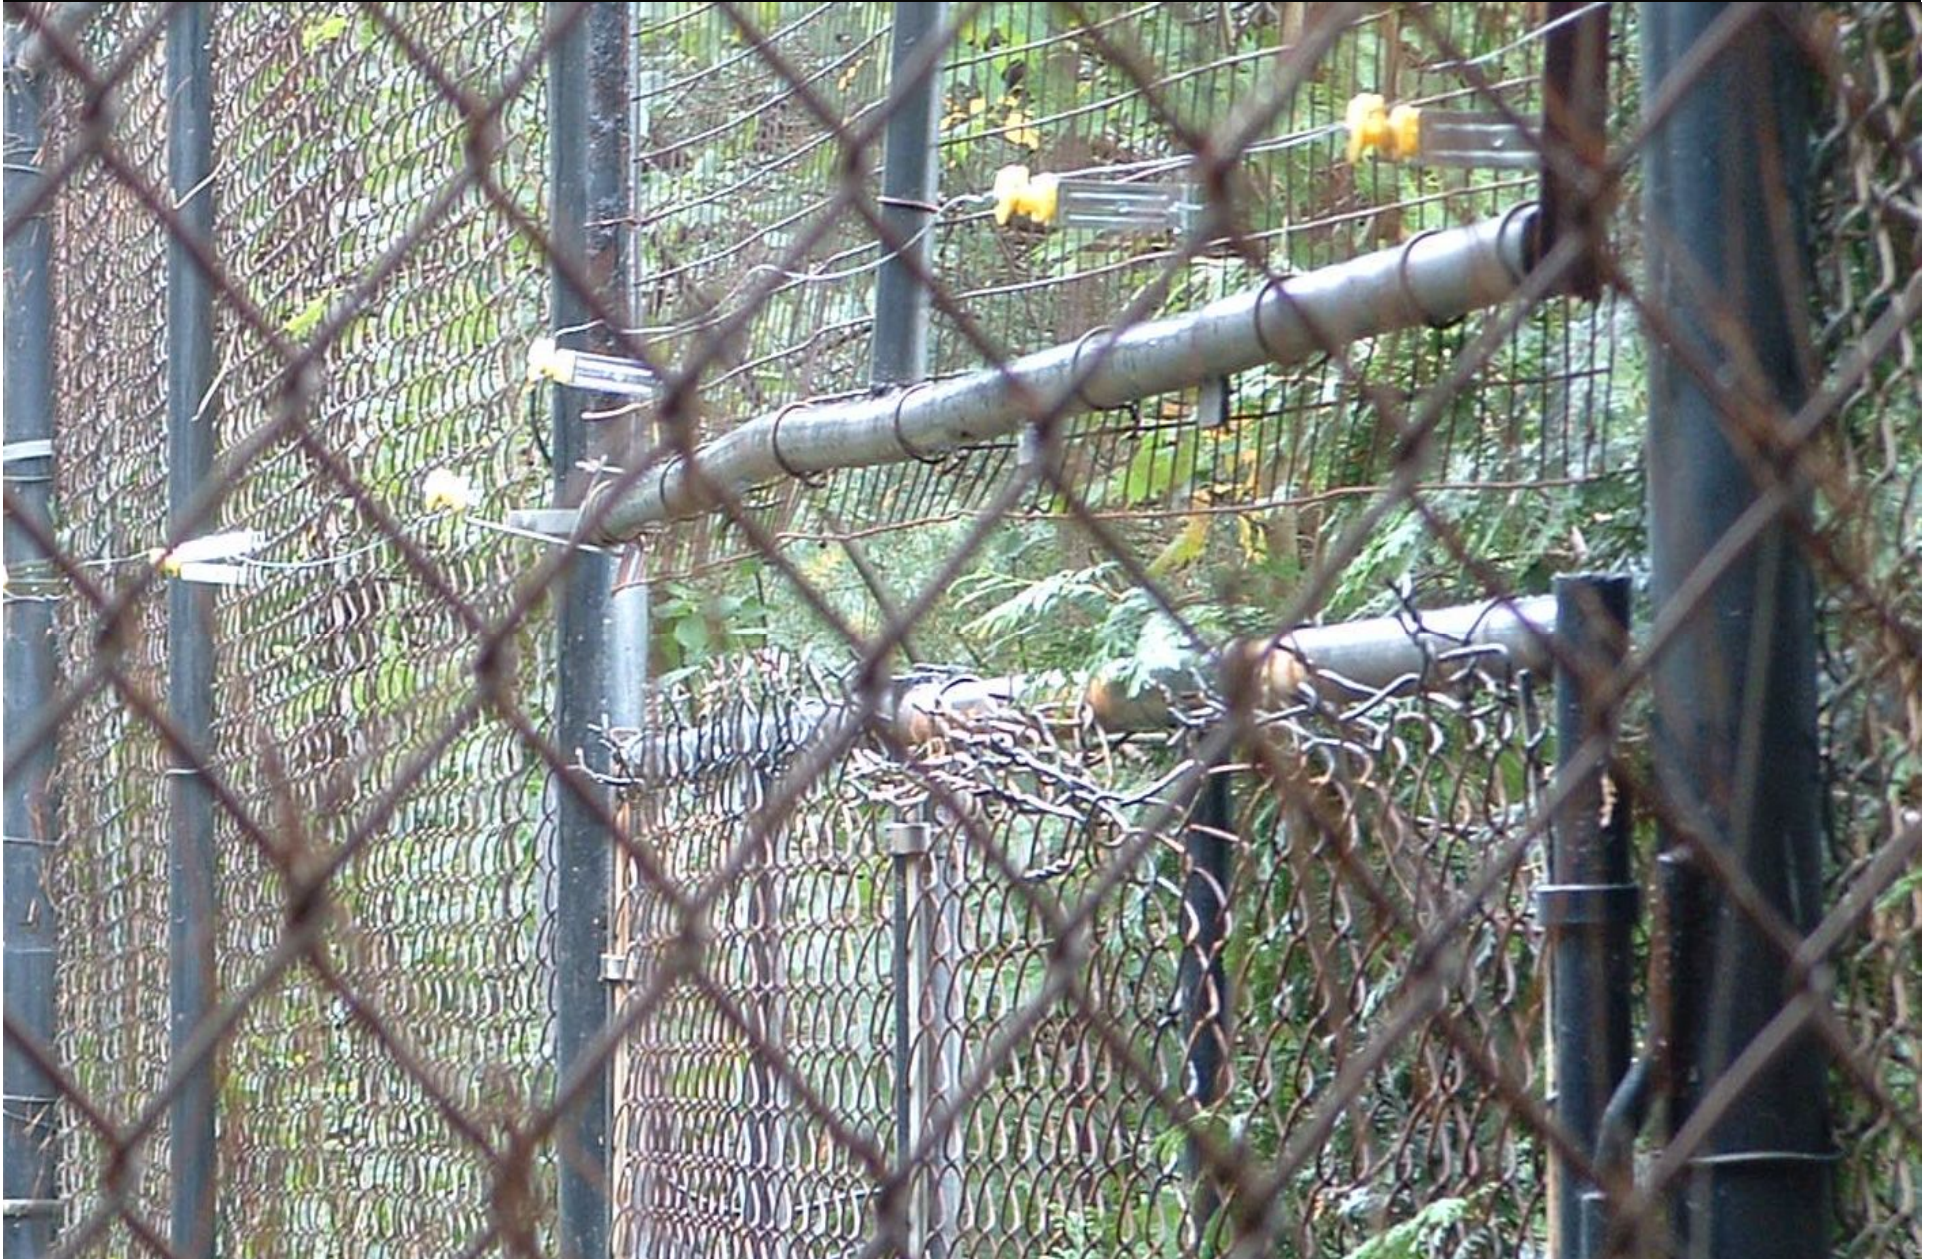
Cougar cage gate does not fit properly into frame leaving significant gap. Bent wire, sharp protruding points. - Spruce Haven Zoo 2010

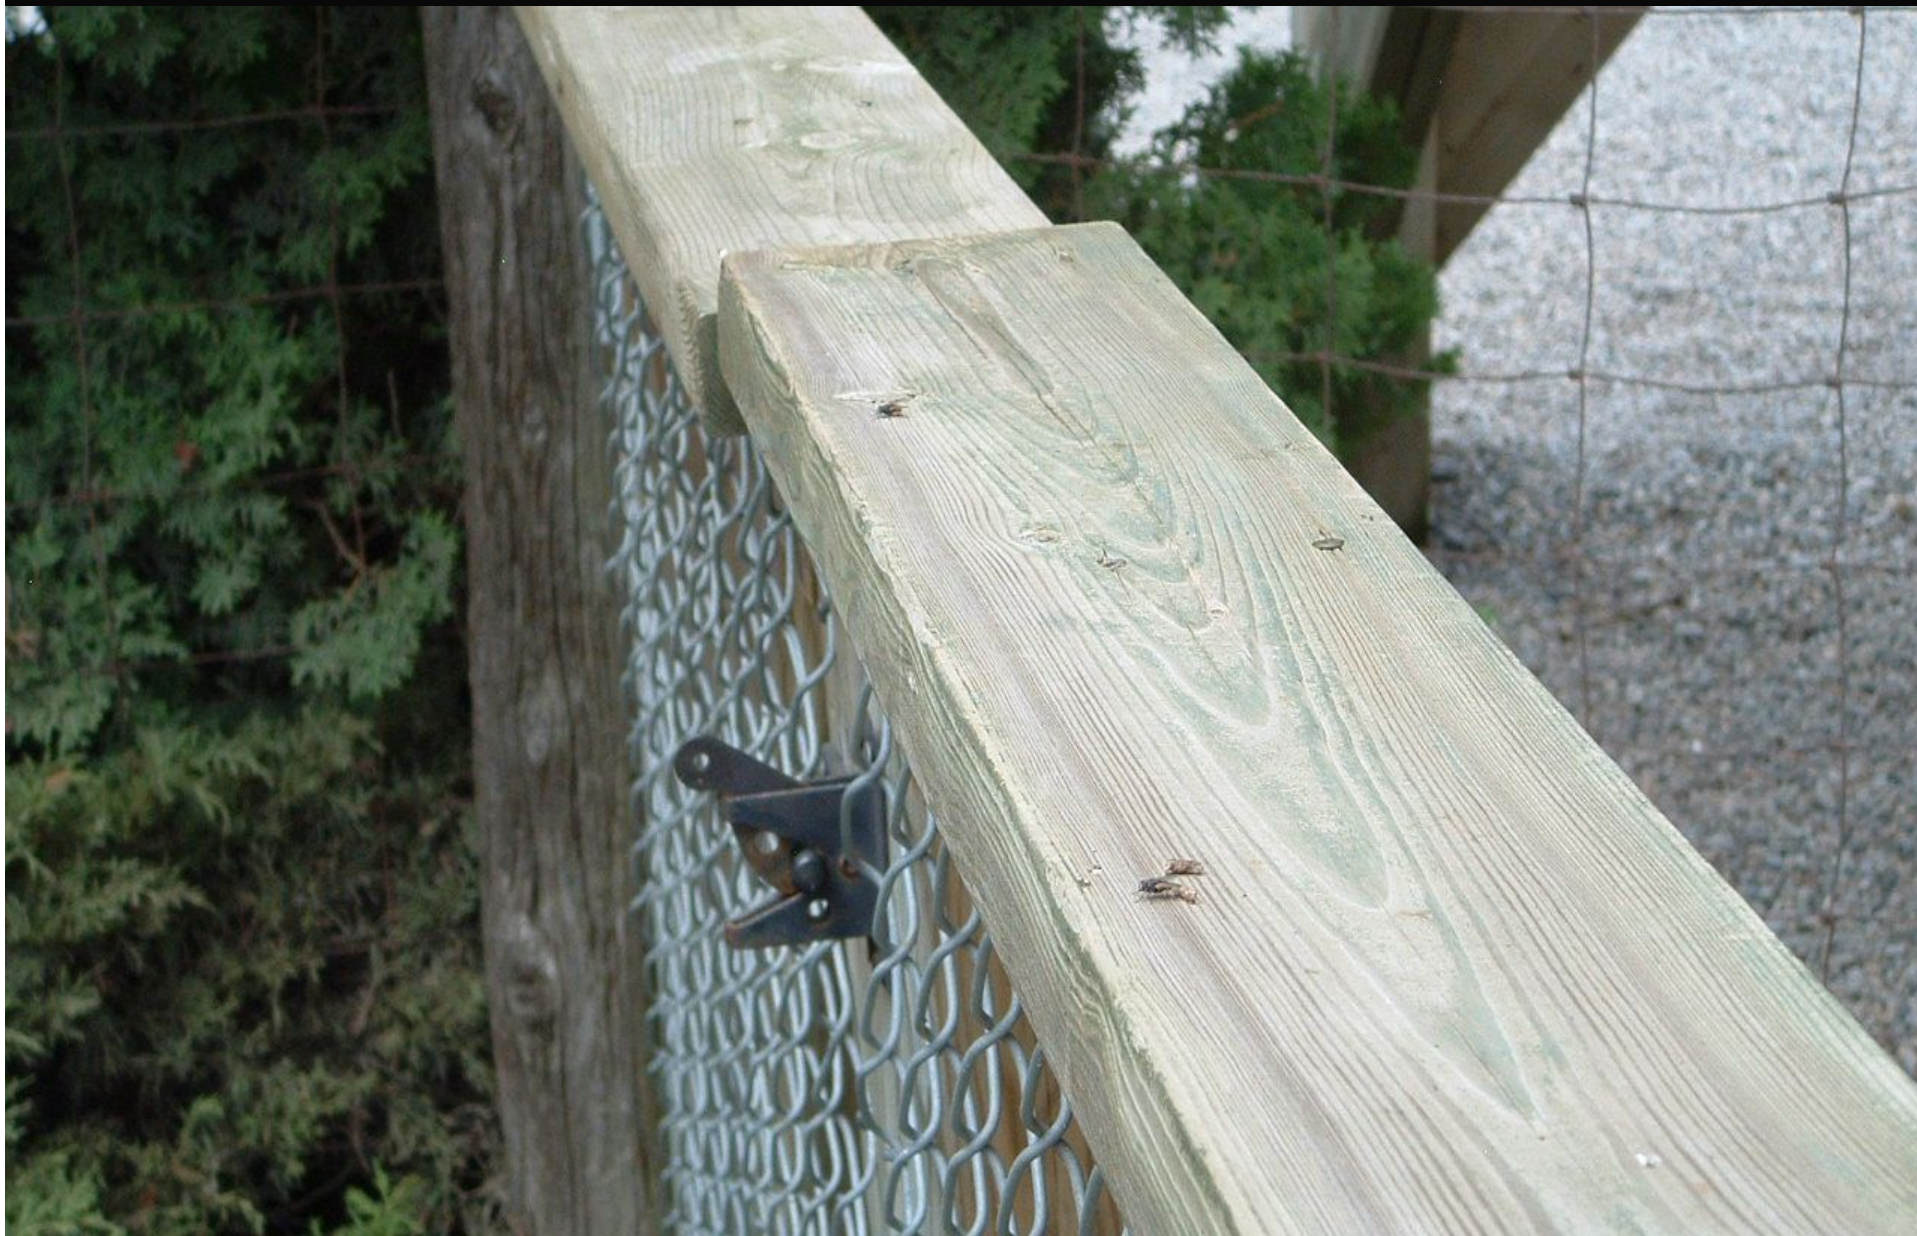
Public stand-off barrier at bobcat and lynx cages secure with simple non-locking gate latch. -  
Greenview Aviaries Park and Zoo 2010

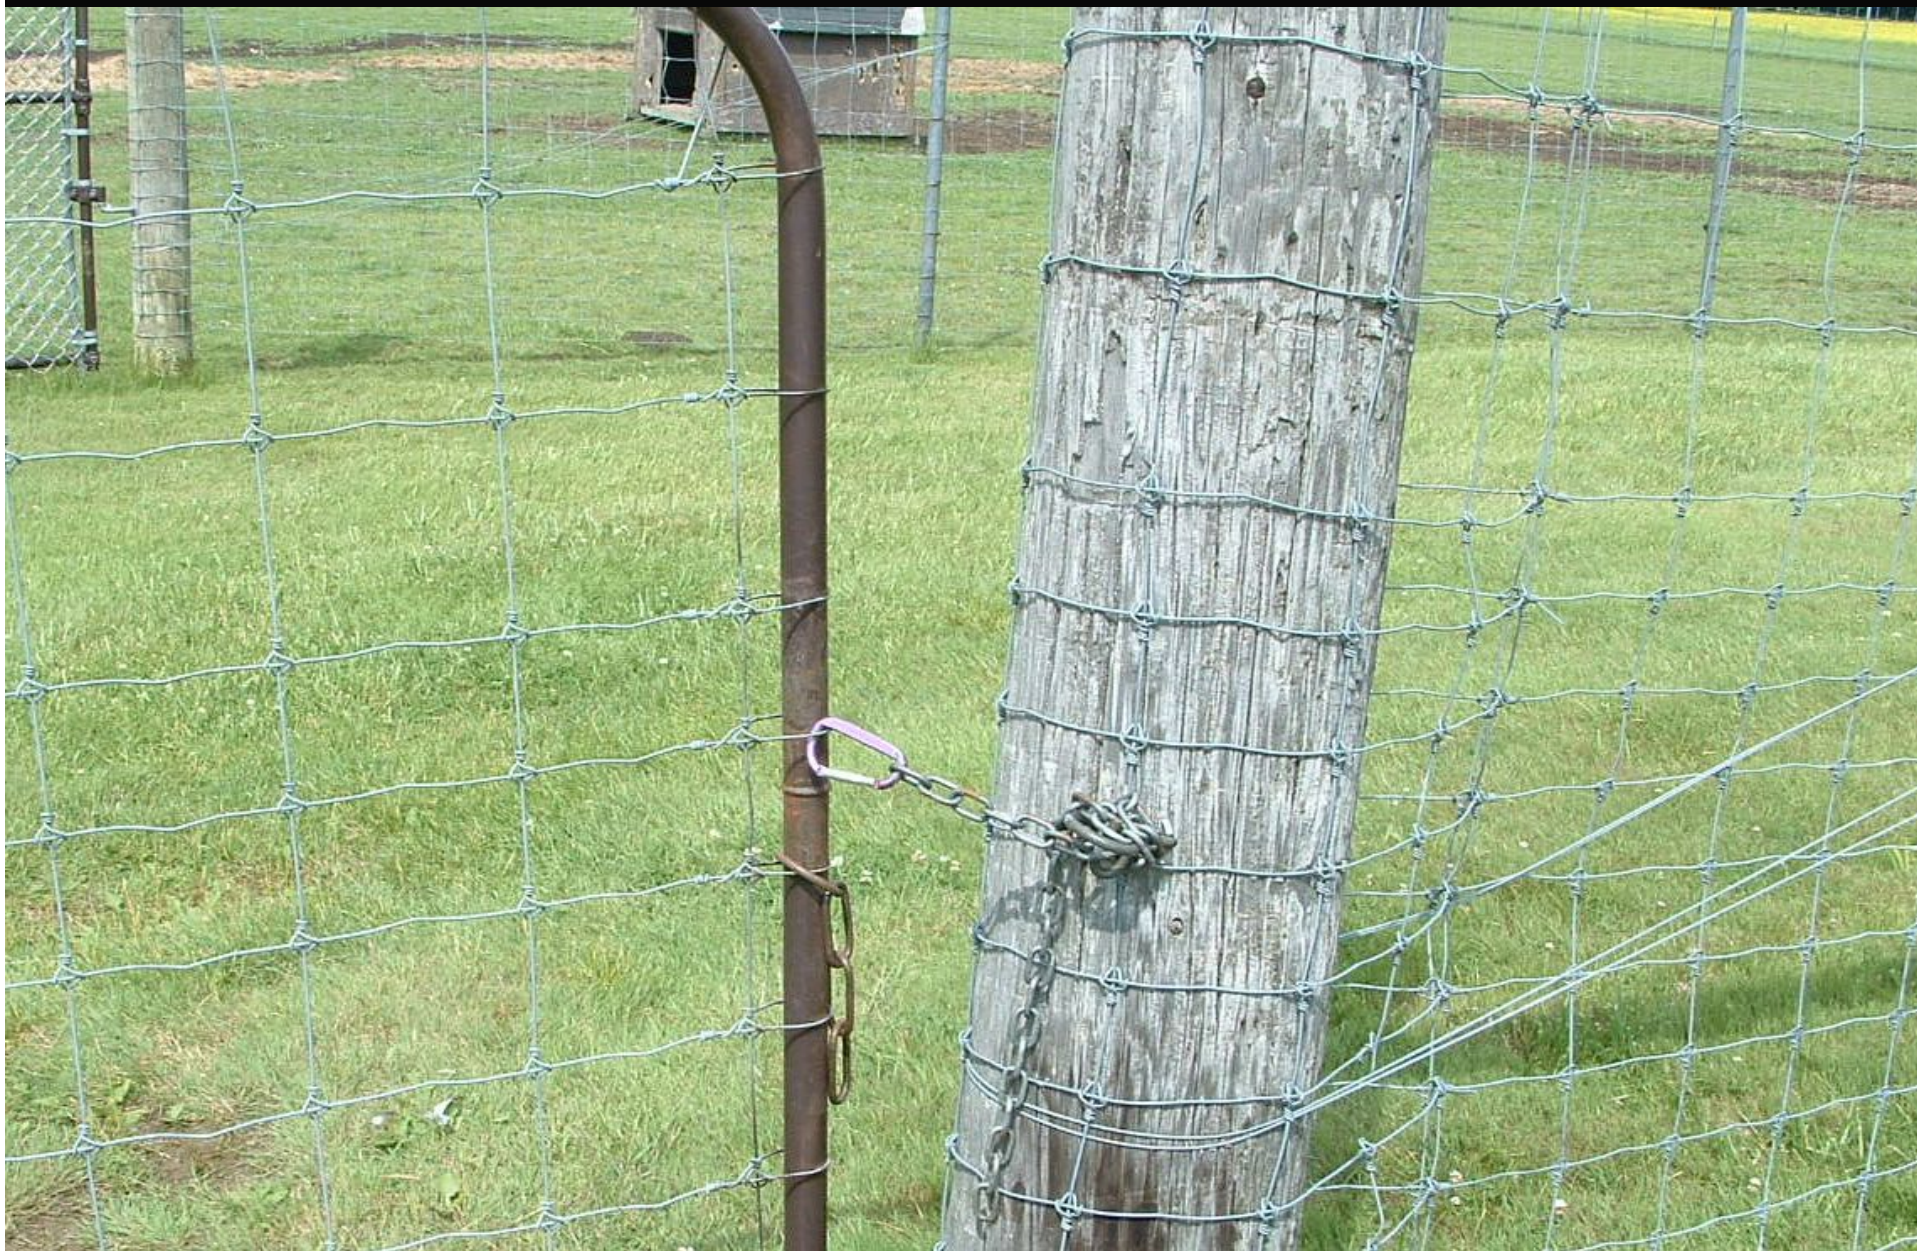
Stand-off barrier gate into tiger and bear enclosure area secured with chain and non-locking carabiner. – Northwood Zoo and Animal Sanctuary 2010

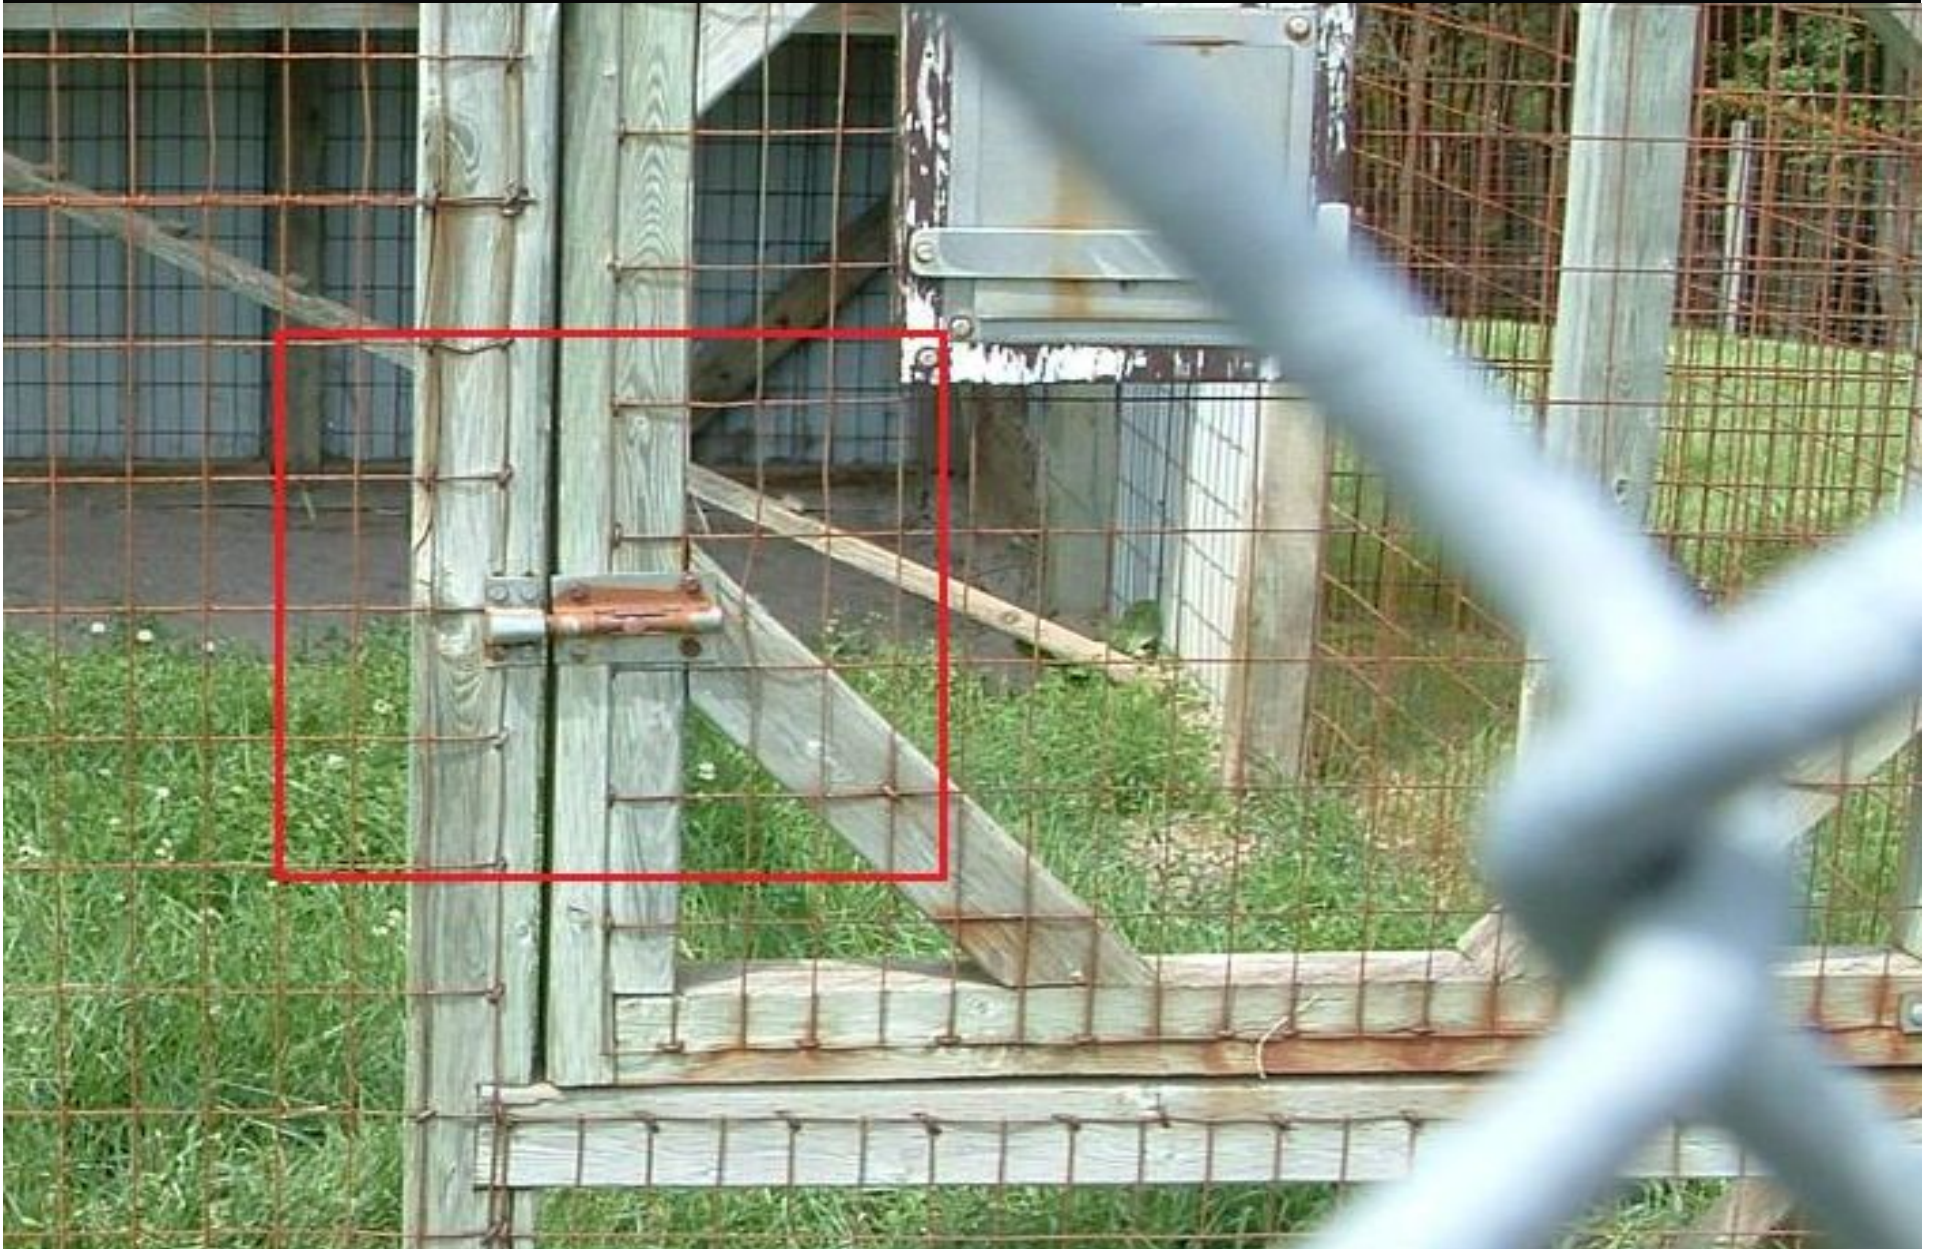
Gate into bobcat cage secured with only sliding bolt. –  
Northwood Zoo and Animal Sanctuary 2010

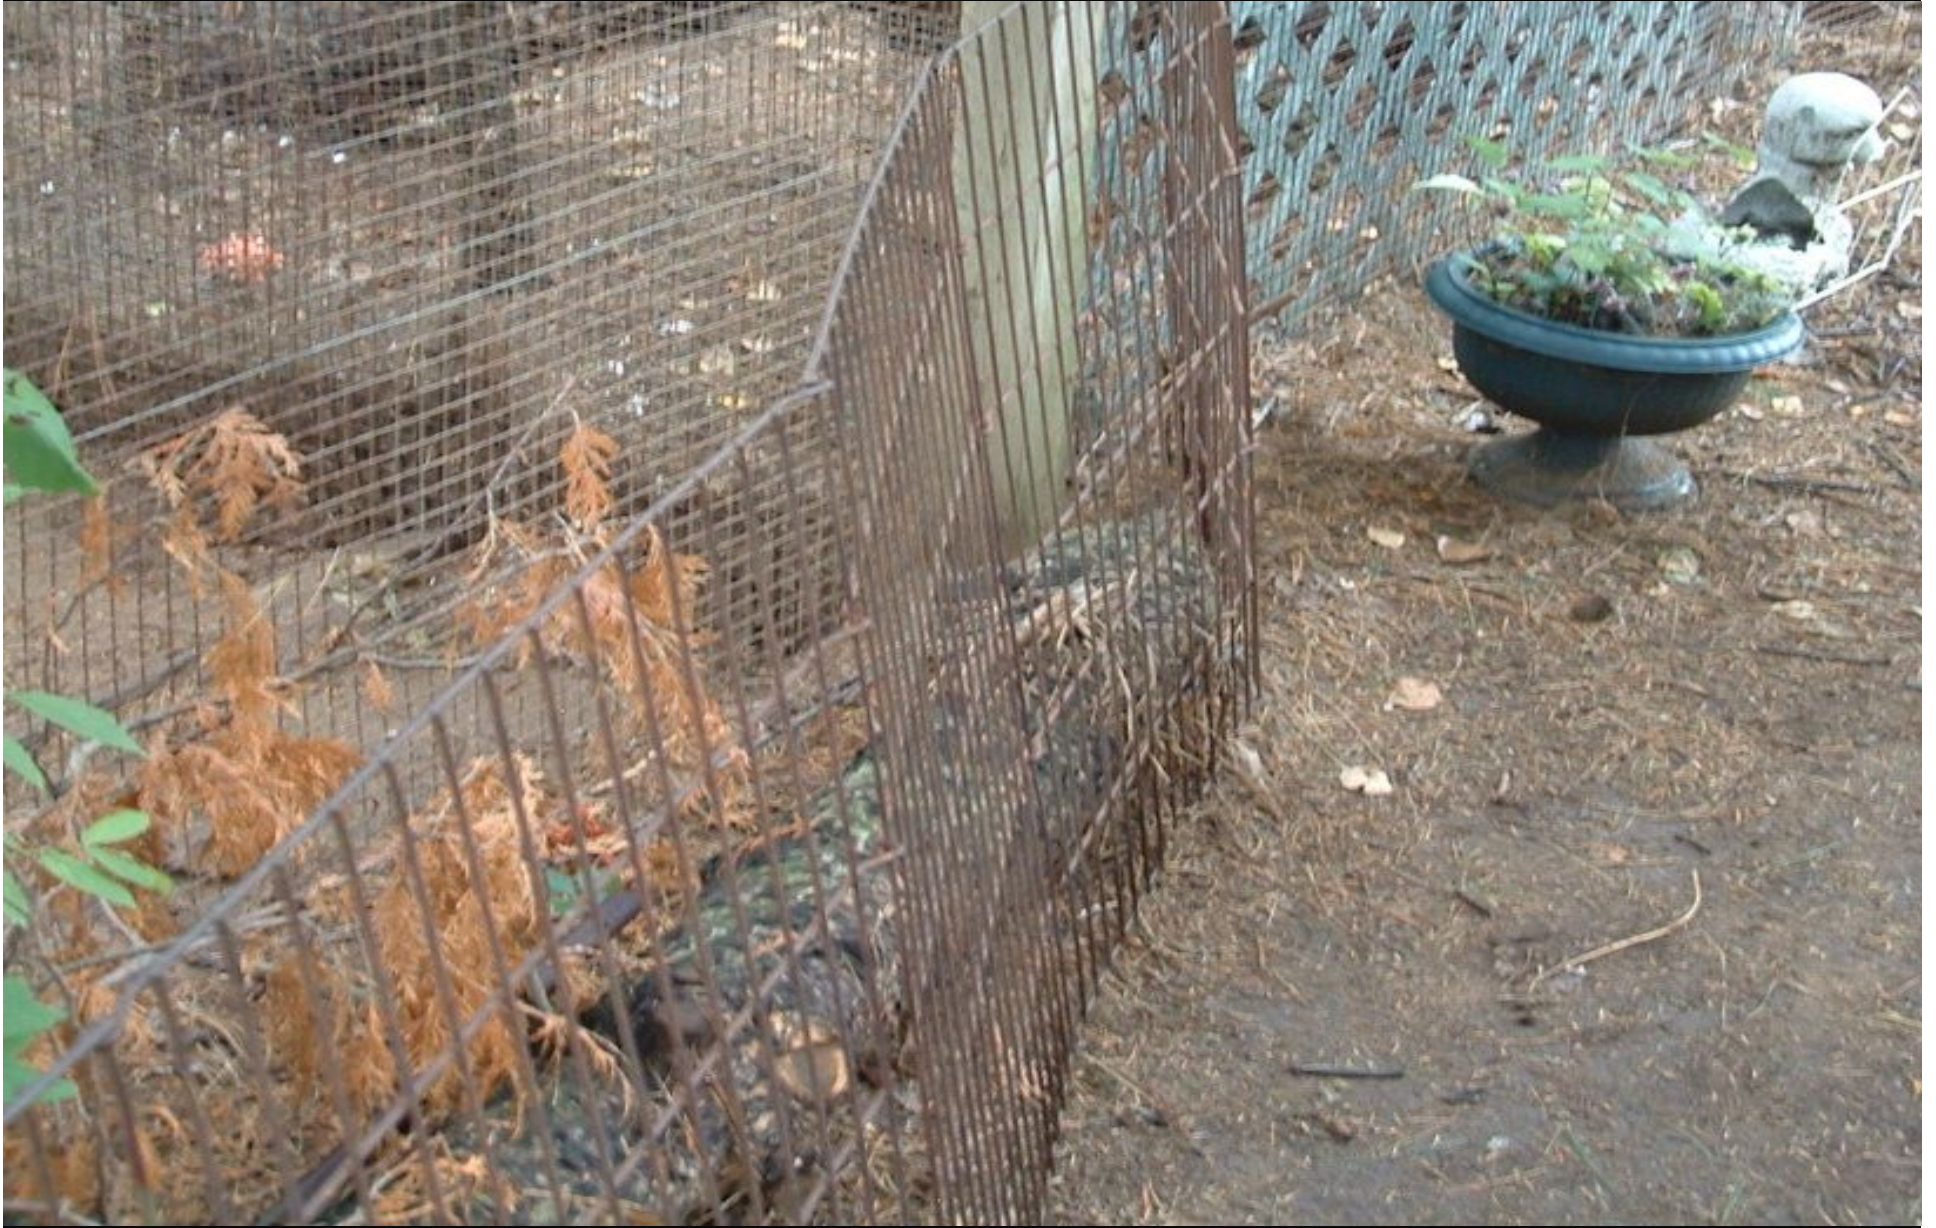
Makeshift public stand-off barrier at coyote and red fox cages does little to keep visitors away from primary barriers. - Spruce Haven Zoo 2010

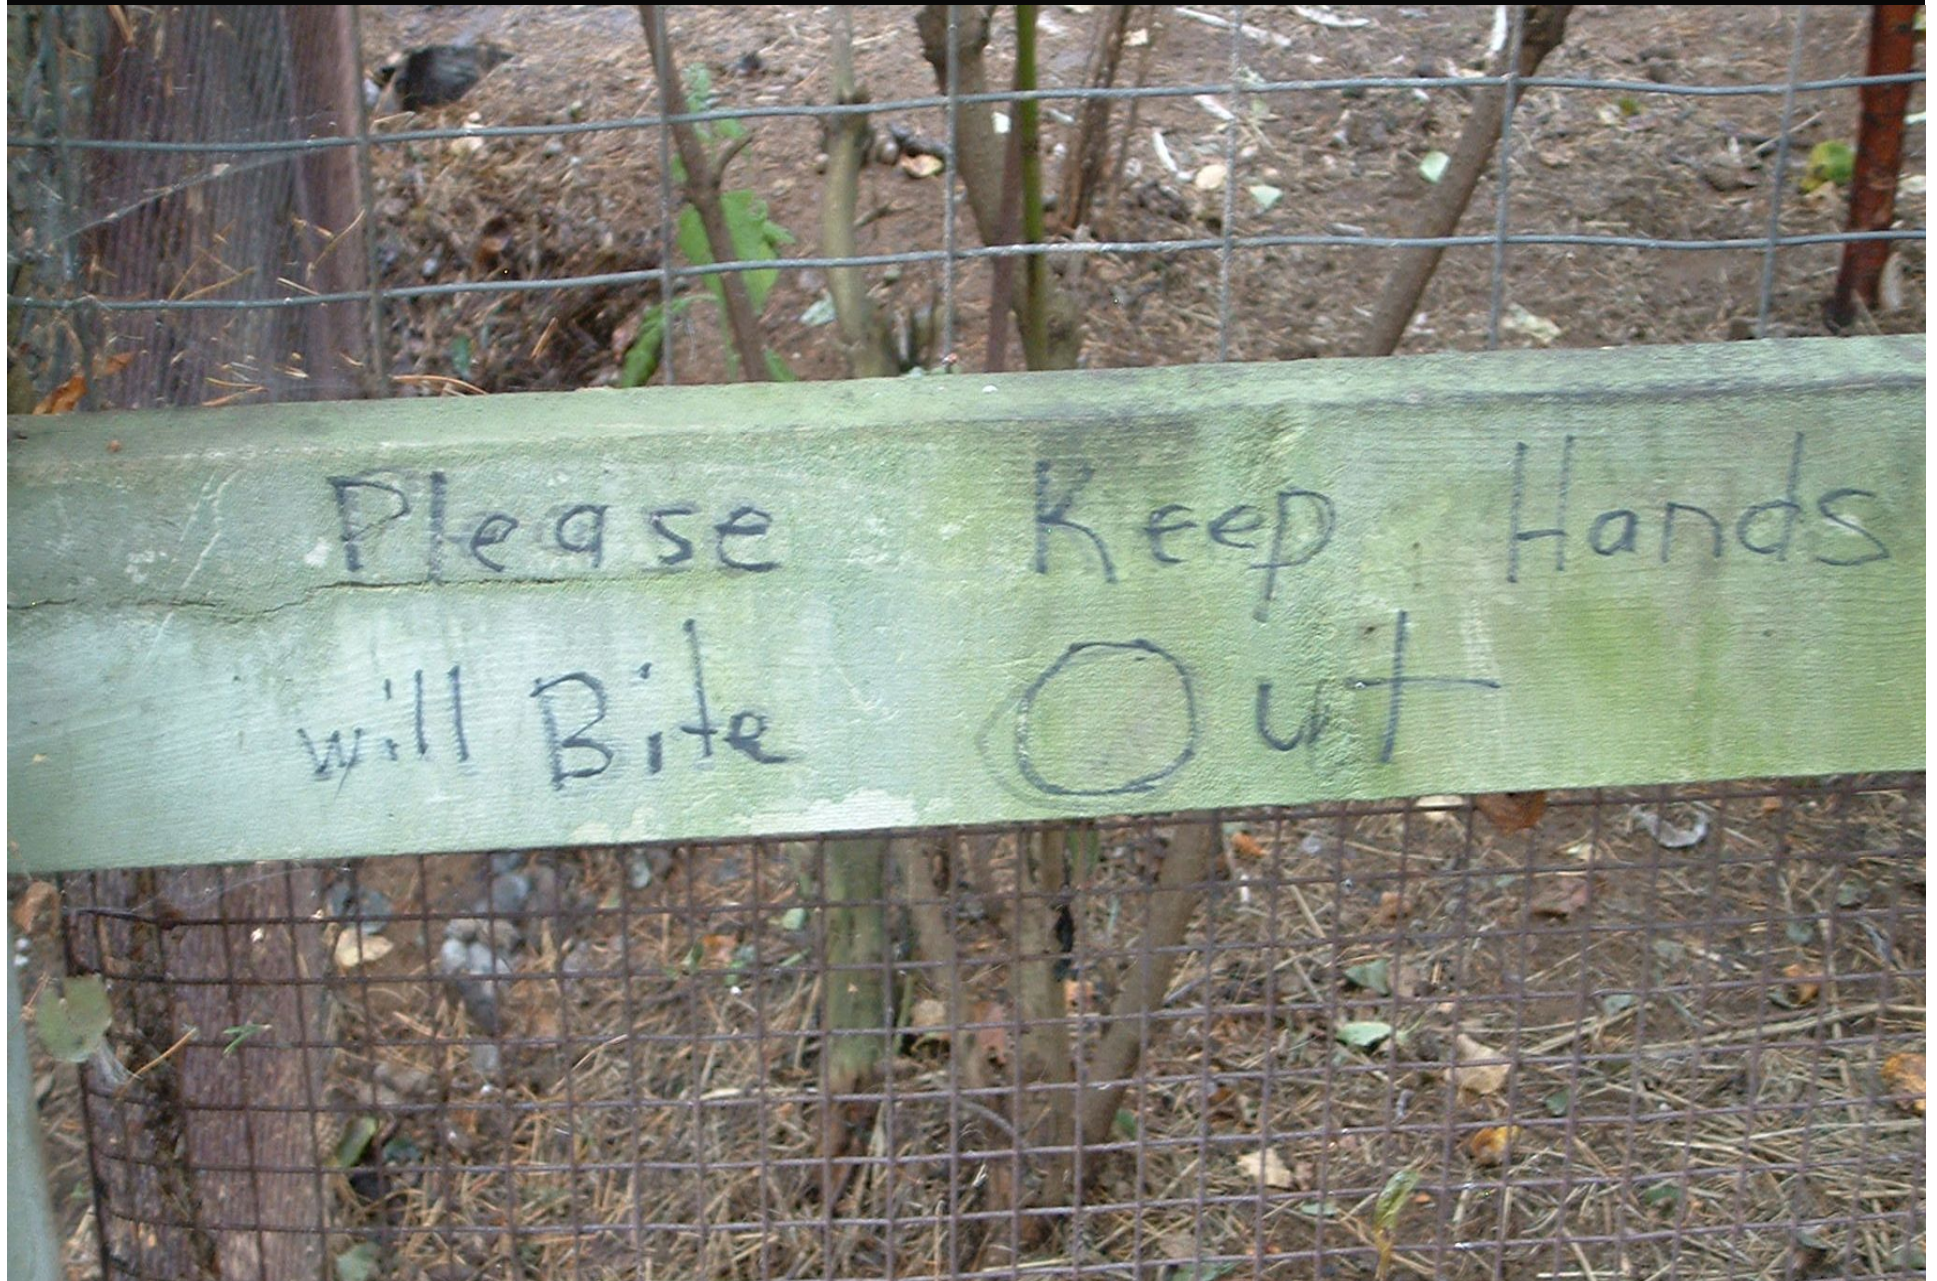
Handwritten warning on lynx cage is easily missed. - Spruce Haven Zoo 2010

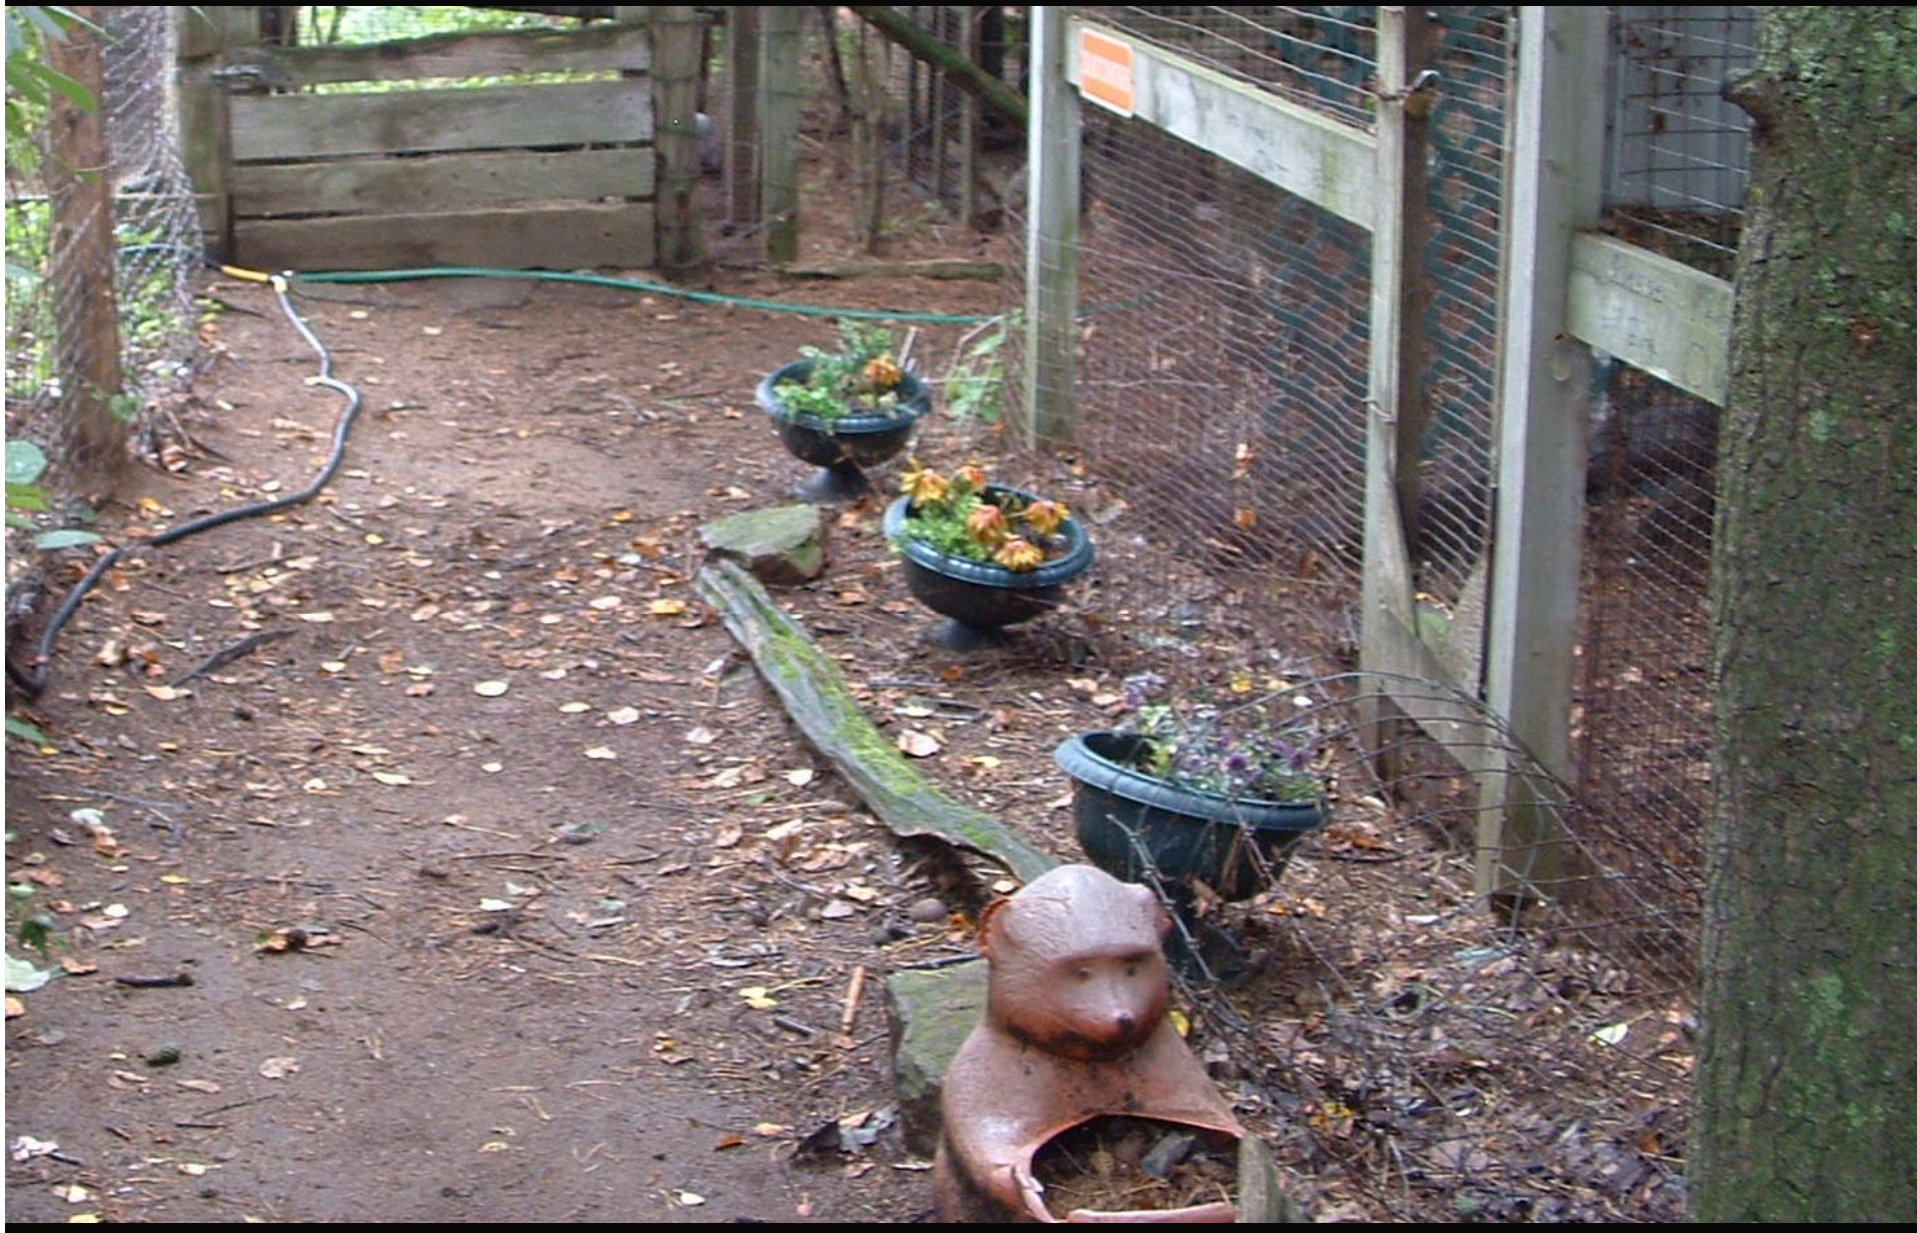
Flowerpots, plastic bear and partial roll of wire used in lieu of proper public stand-off barrier at raccoon and lynx cages. - Spruce Haven Zoo 2010

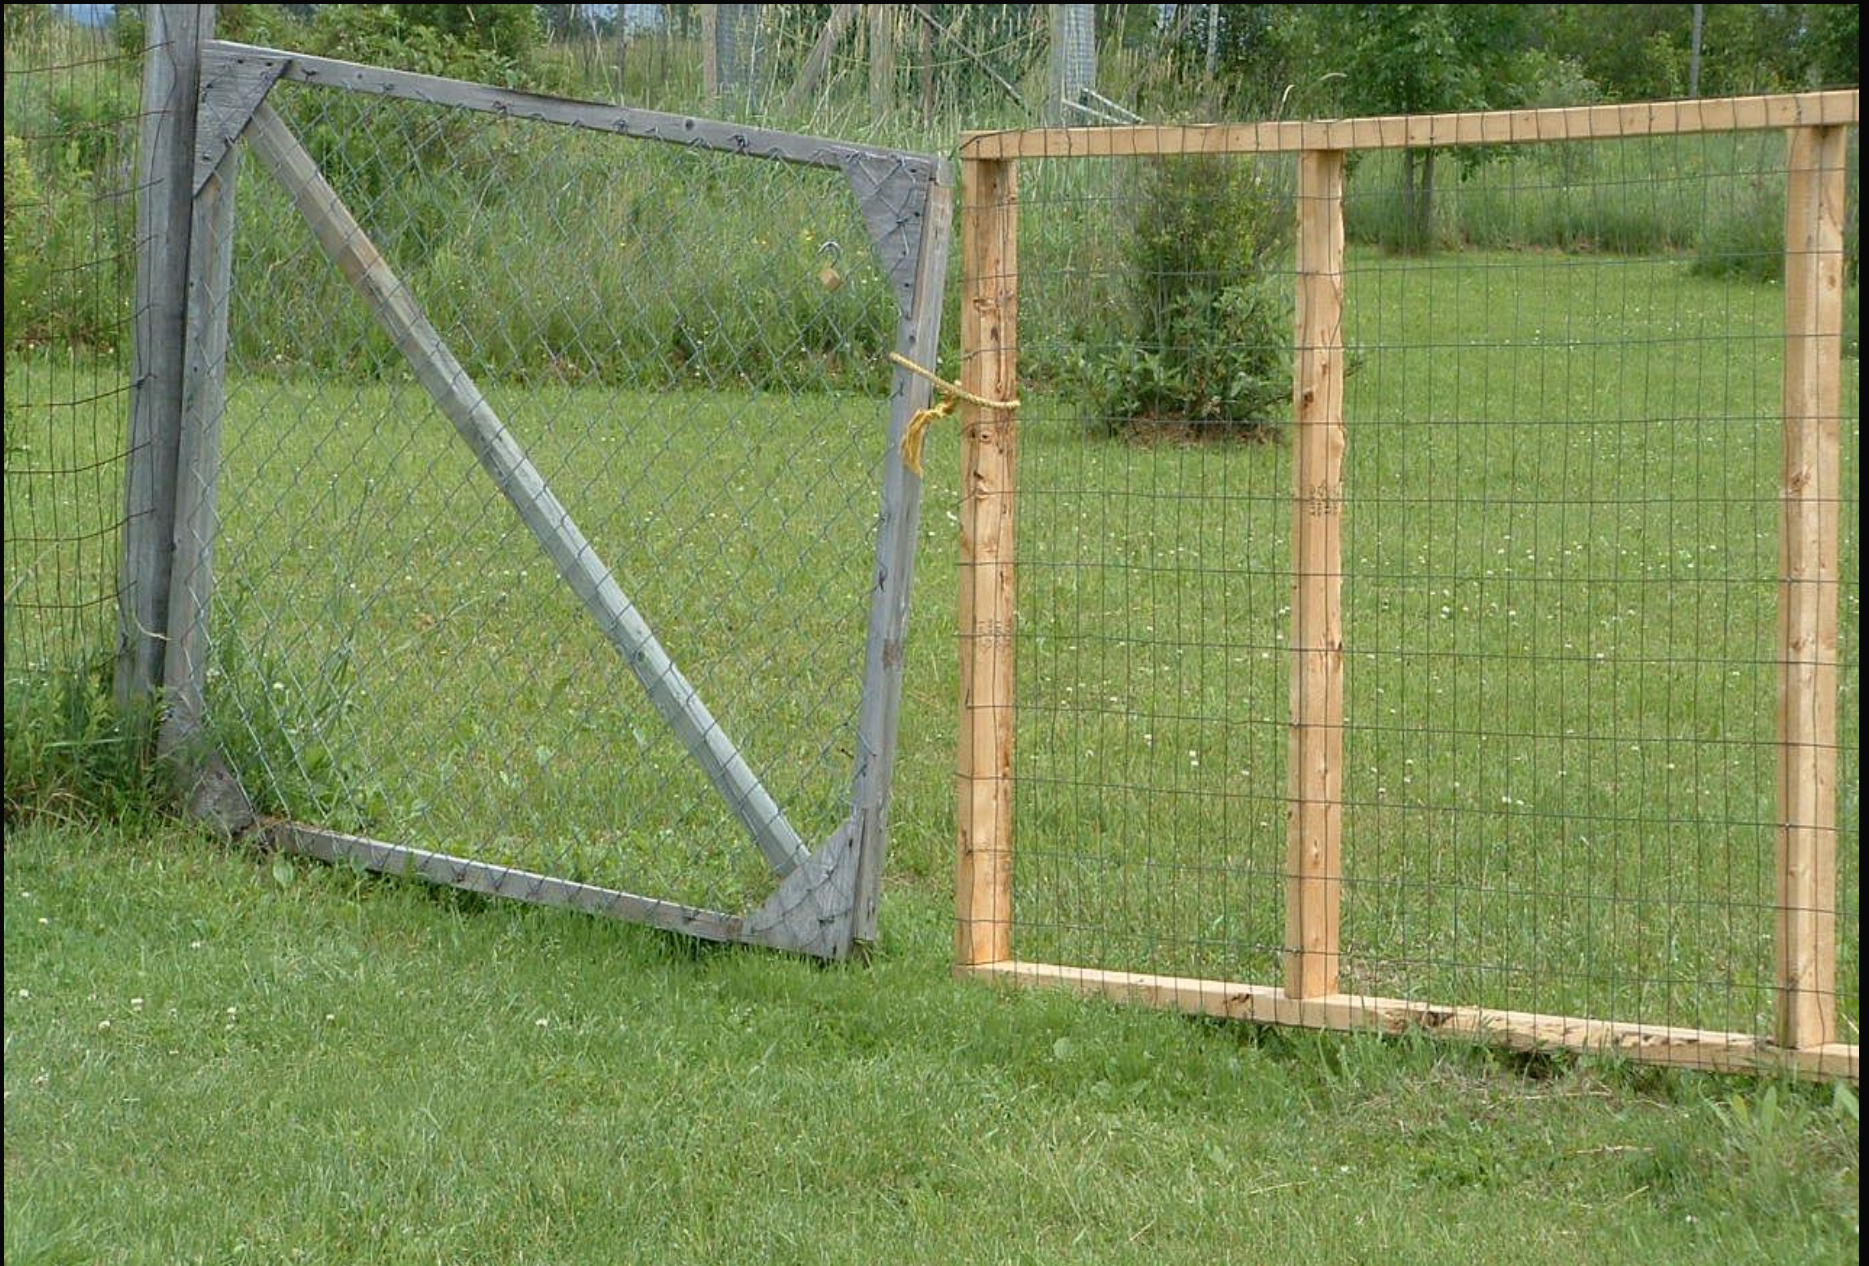
Stand-off barrier gate leading to several animal enclosures secured with piece of rope instead of lock. – Papanack Park Zoo 2010
